199 Color TV Troubles & Solutions

by R. L. Goodman

FIRST EDITION

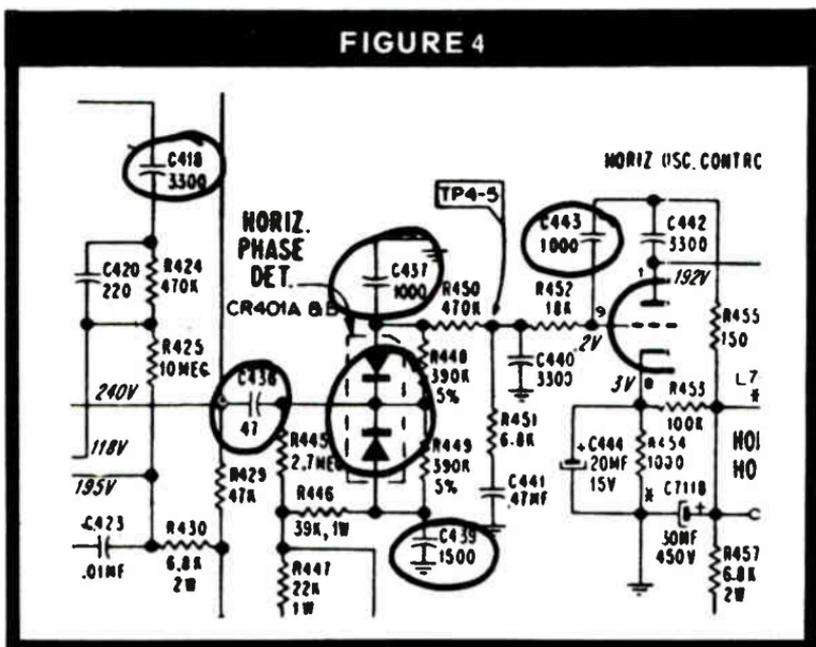
FIGURE 4

This color TV receiver had developed an unstable horizontal hold condition. For this symptom make the following quick checks. With a jumper lead, short test point TP4-5 to ground, thus, removing the correction voltage from the AFC. With the horizontal hold control we should be able to lock in a picture, but it will have a slight drift. With the jumper lead removed the picture should now sync in and lock. If you cannot lock in a picture with the hold control, the problem is in the oscillator. If the oscillator is normal, the fault is in the control circuit. The following components are the most likely ones to fail in the oscillator; C442, C443, C444, C445 (not shown in Fig. 4), or C711B, and the horizontal hold coil. In the horizontal control circuit (Fig. 4) check C418, C436, C437, C439, and dual-diode CR401.

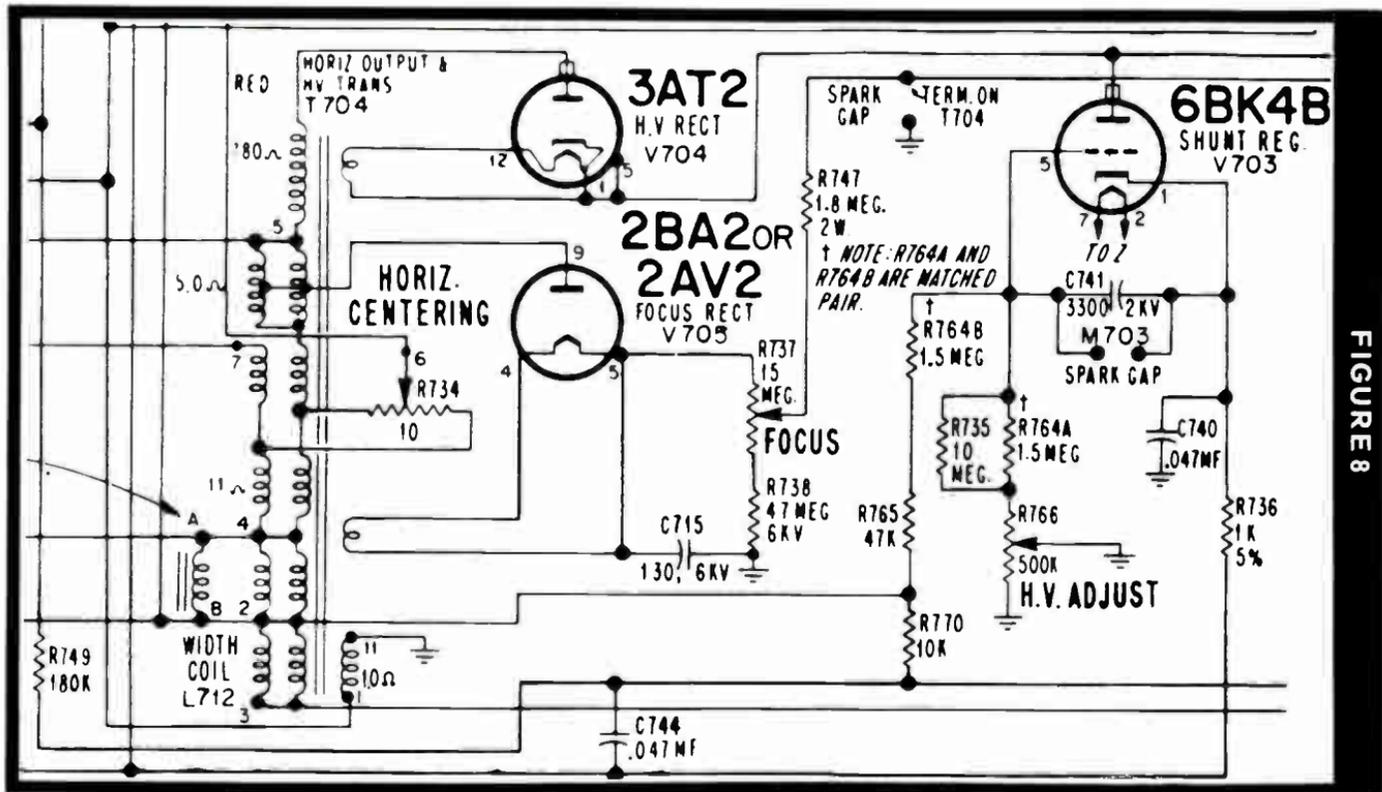
FIGURE 8

In some of these chassis, the focus control is wired as a rheostat instead of a potentiometer. A 1.8 meg resistor (R747) has also been added (see Fig. 8). This modification should be made whenever you replace the focus control in an H10 or H12 chassis. If the focus range is not adequate after this modification, try a lower value for the added resistor (R747), 1.0 meg, for instance, but keep the value as high as possible.

Notice that control part numbers 75C108-1, -2 and -3, are electrically interchangeable, differing only mechanically. All three can be used for replacement. The -1 does not have a shaft. While the -2 and -3 both have shafts but slightly different terminal lug arrangements.

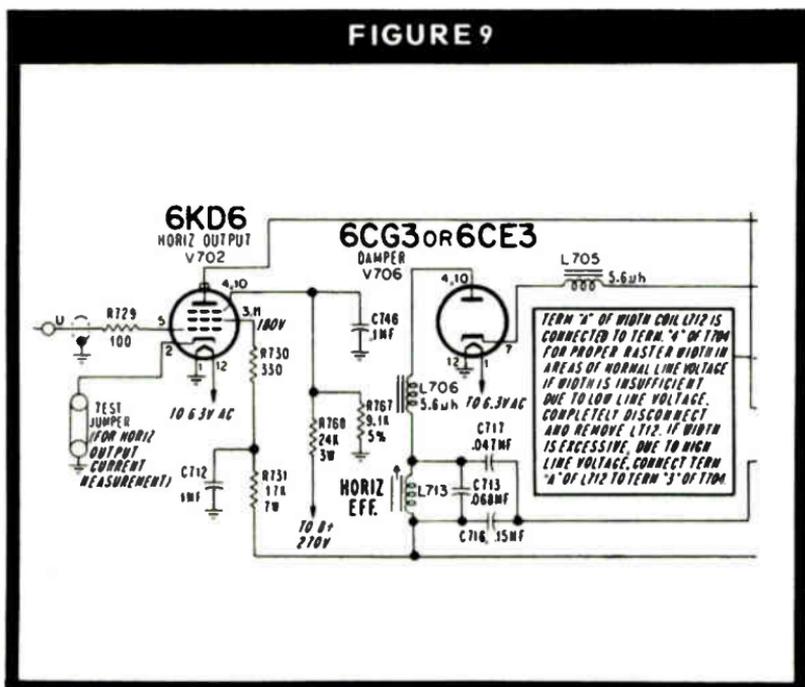
FIGURE 9

This color chassis displayed a picture with insufficient width. The raster was out of focus and the 6KD6 H.O.T. was pulling excessive current. Of course, you must change all of the horizontal sweep section tubes. Next, correct by adjusting the horizontal efficiency coil, as this coil may be turned out too far, giving the above results. Connect the current meter and adjust coil L713 until a dip of the least amount of current is noted on the meter. This adjustment should be made whenever a routine current check is performed. Examine horizontal efficiency coil L713 for any burned marks. If in doubt, change it. Refer to Fig. 9.

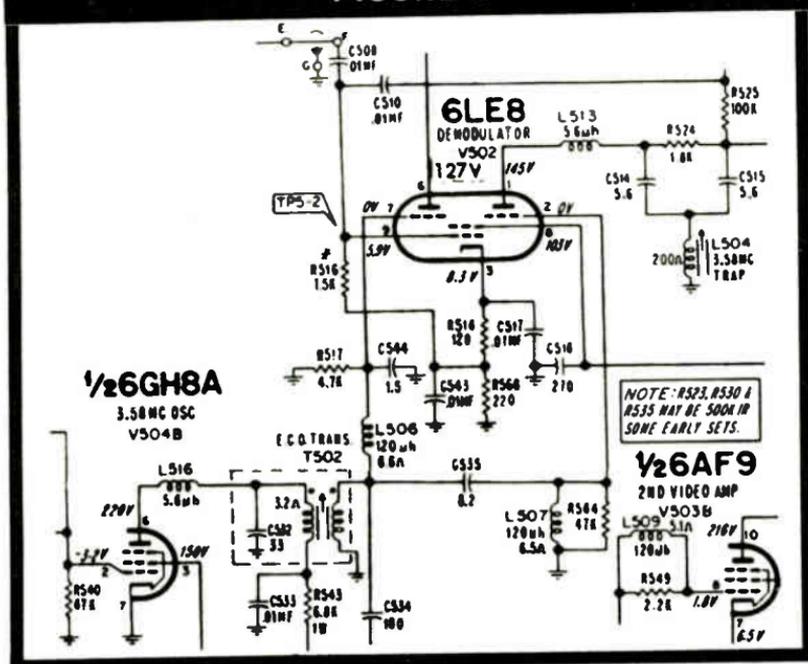
FIGURE 10

Make the following checks: Test for failure of phase coils L506 and L507 (replacement Part No. 73B55-26). A breakdown of the spark gaps in the CRT leads is a possible cause for failure of these coils.

Two types of spark gaps have been used. Late production sets use a "Gap-Cap," while early production sets use a twin-lead type gap. Some of the early spark gaps have been found with the insulation protruding past the wire ends. The ends of the wires must be exposed in order for the gap to operate. Trim the twin-lead insulation until the ends of the wire are exposed slightly beyond the insulation. The exposed ends must not be moved from their original spacing. Replacement of either L506 or L507 without checking the spark gaps may result in repeated coil failures. The schematic for this color section circuit trouble is shown in Fig. 10.

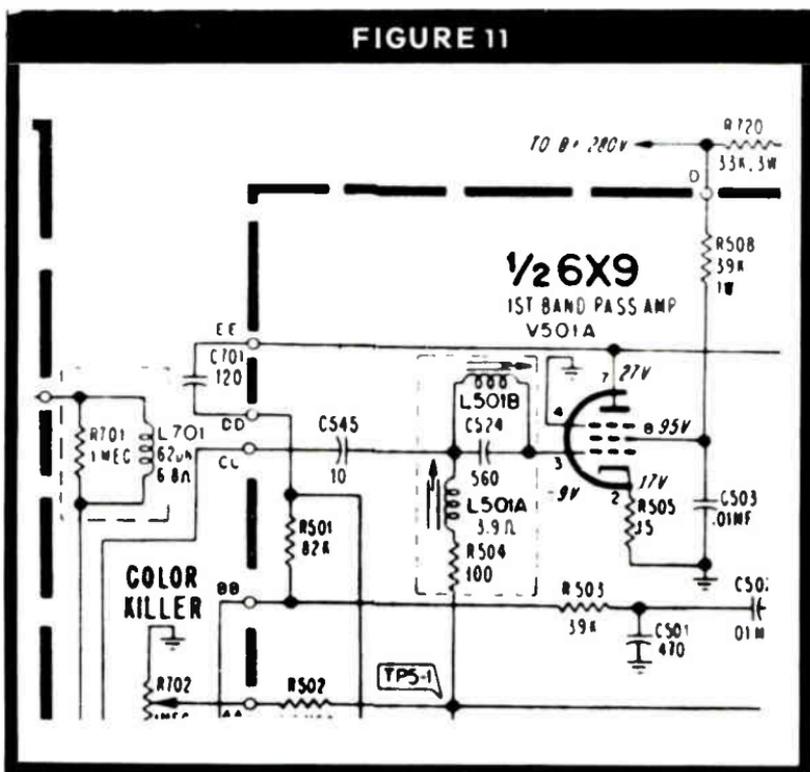
FIGURE 11

This color set was working fine, except the flesh tones would shift drastically with a camera change. Colors would go from normal to purple from camera to camera (some color programming may seem to be normal), in which case the voltage on the grid (pin 1) of the burst amplifier (6AF4) will have considerably more positive voltage than shown on the schematic. The screen may also go green for an instant. This shifty color problem was caused by a leaky capacitor C701 with a value of 120 pf, shown in the schematic of Fig. 11. If the color fades out on some channels, but other TV stations are good, try readjusting the color killer control for all stations received.

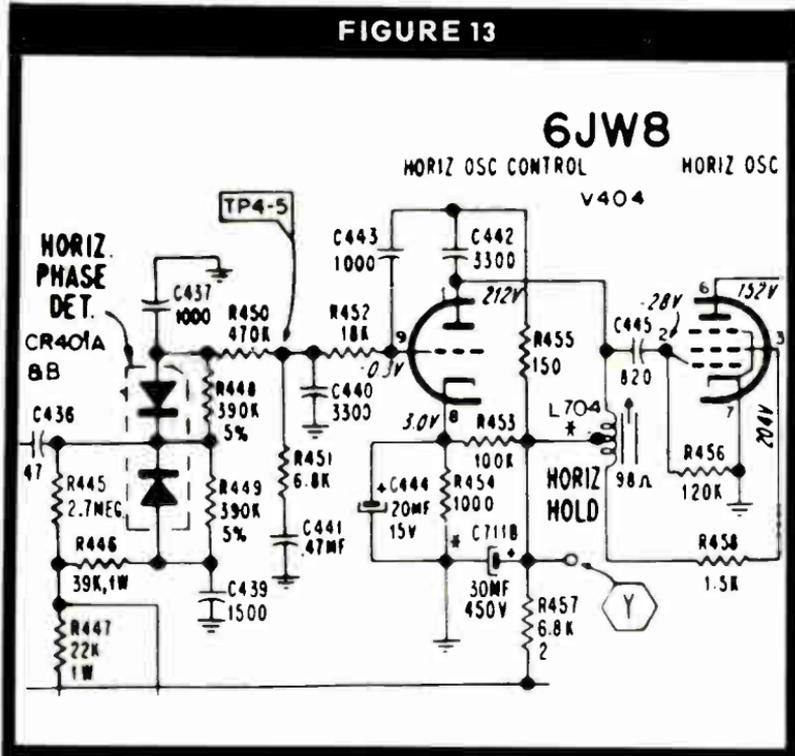
The most obvious symptom for this set was a loud horizontal squeal. There was no picture or high voltage. A few voltage checks in the horizontal oscillator and sweep output stage were about normal; however, the drive voltage was low. With a few scope checks, we learned that the oscillator frequency was too high. The trouble was caused by a faulty C711 capacitor shown in the horizontal oscillator circuit, Fig. 13. This is a 30 mfd, 450v filter capacitor.

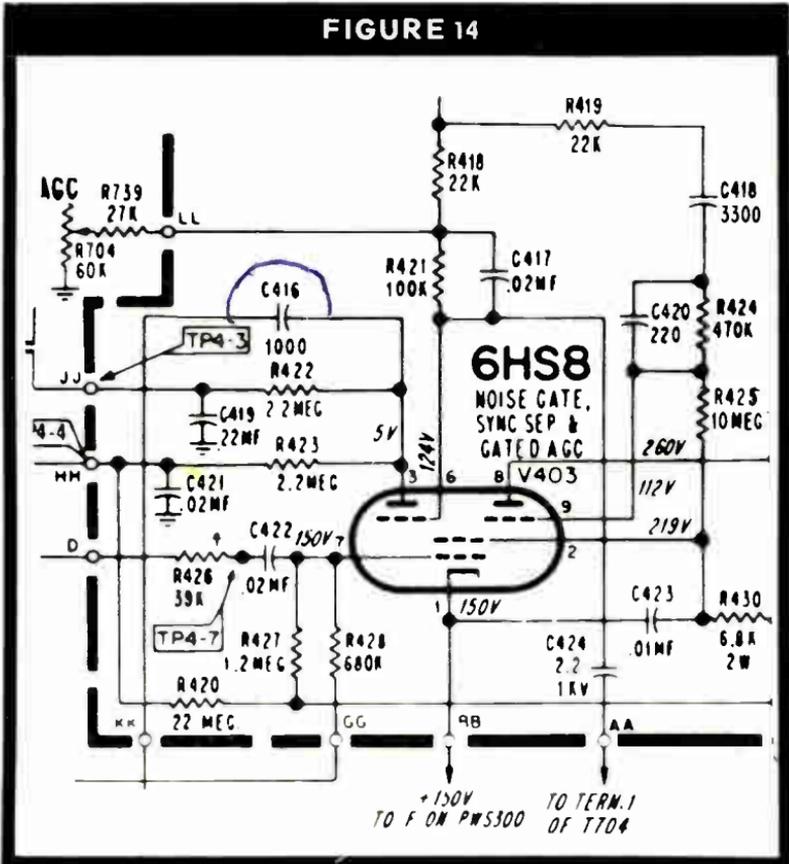
FIGURE 14

The picture and sound were good on the weak signal TV channels, but the picture indicated circuit overload on a strong TV station. All of the voltages shown in the sync and AGC circuit of Fig. 14 were checked and found correct. The trouble was located as a leaky C416 capacitor. This .001 mfd capacitor feeds the horizontal keying pulse to the plate of the AGC stage. After the capacitor was replaced and the AGC control adjusted, all stations were received clearly.

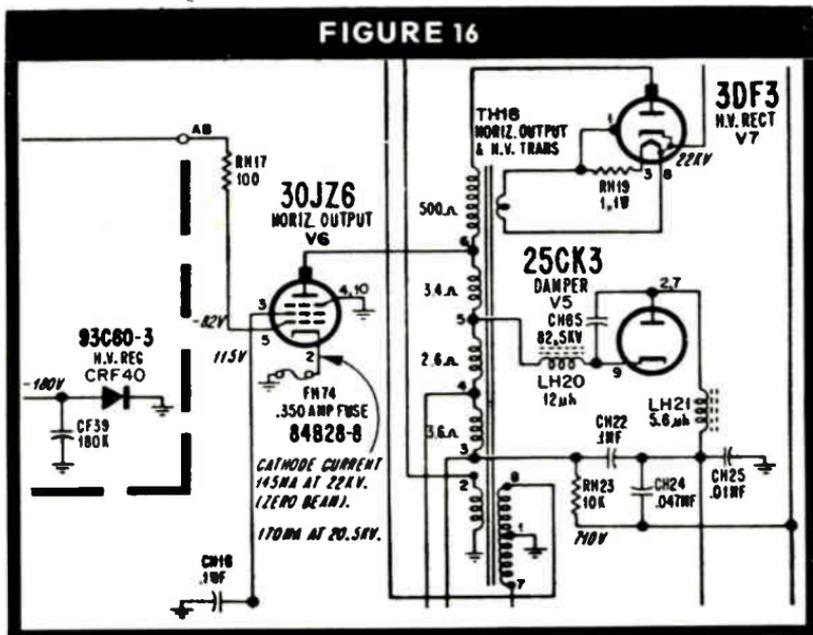
FIGURE 16

Also check the current of the horizontal output tube, and don't run the CRT screens too high. With the screen, contrast and brightness controls turned up, this chassis will draw over 230 ma of current and "wipe-out" the sweep transformer. For a current check, use a burned-out bell fuse. Remove the plastic cap and clip two leads from the bell fuse to the current meter. To remove the HV rectifier tube (3DF3), you must first remove the horizontal output and damper tubes from their sockets before you can open the HV door cover. Should the 4K10 chassis keep "blowing" the bell fuse, suspect an intermittent short in the horizontal output or damper tube. Monitor the current meter and reset the screen controls if necessary.

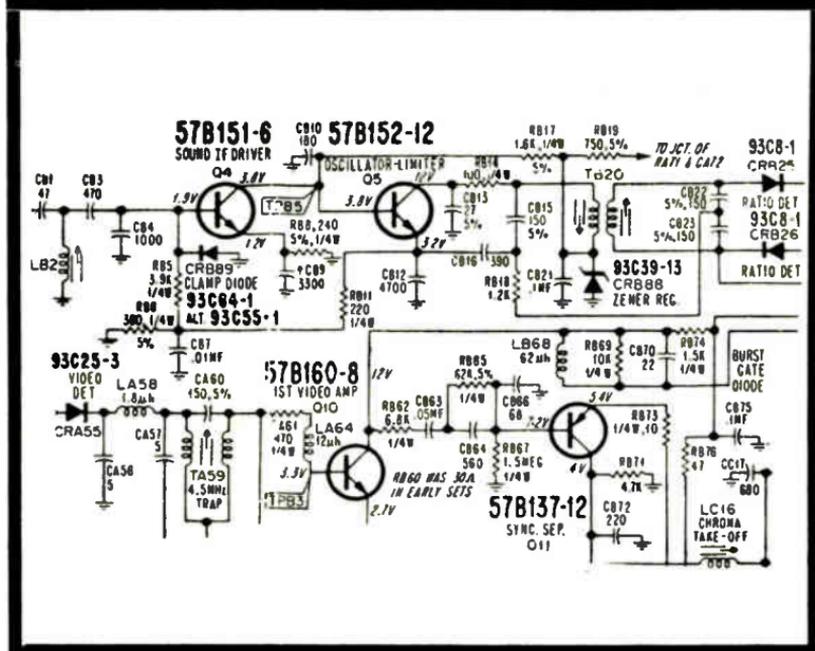
FIGURE 18

For a no sound or distorted sound condition, check Q3, Q4, and Q5 in the IF sound section. See sound section circuits in Fig. 18. Check the condition of diodes CRB25 and CRB26. Check CRB88 for correct voltage regulation to Q5. Also check CB12 (4700 pf) for very sharp sound tuning.

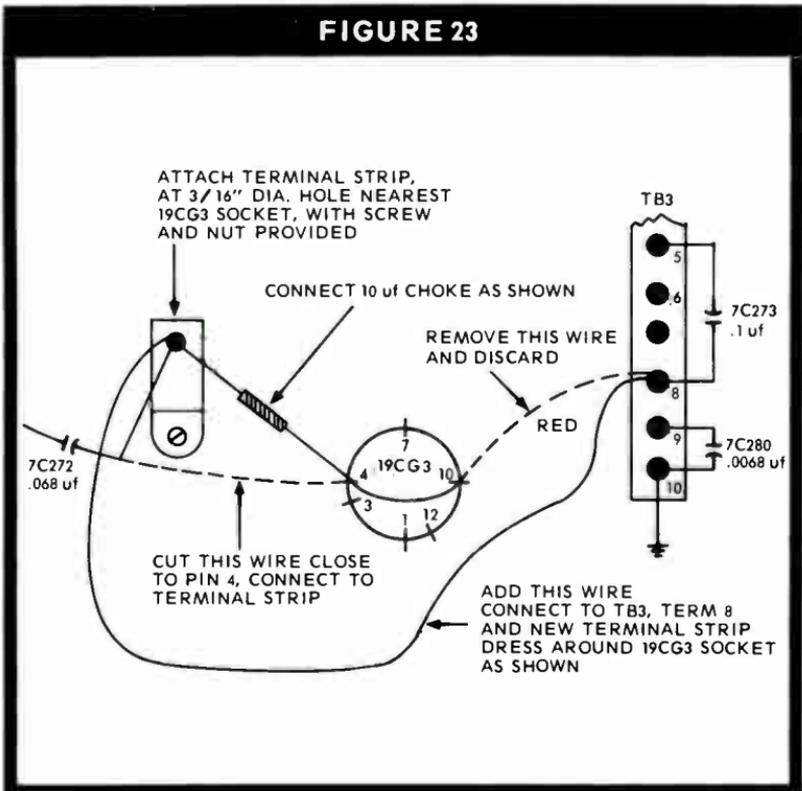
FIGURE 23

Some of these GE chassis will exhibit a watery line at the extreme left of the screen under weak signal conditions. This is caused by an oscillation in the damper circuit. The oscillations or "damper hausen" can be eliminated by connecting an RF choke in series with the damper tube plate, pin 4 of the 19CG3 tube. Later production chassis are equipped with this choke. Refer to the drawing in Fig. 23 for the modification to be made.

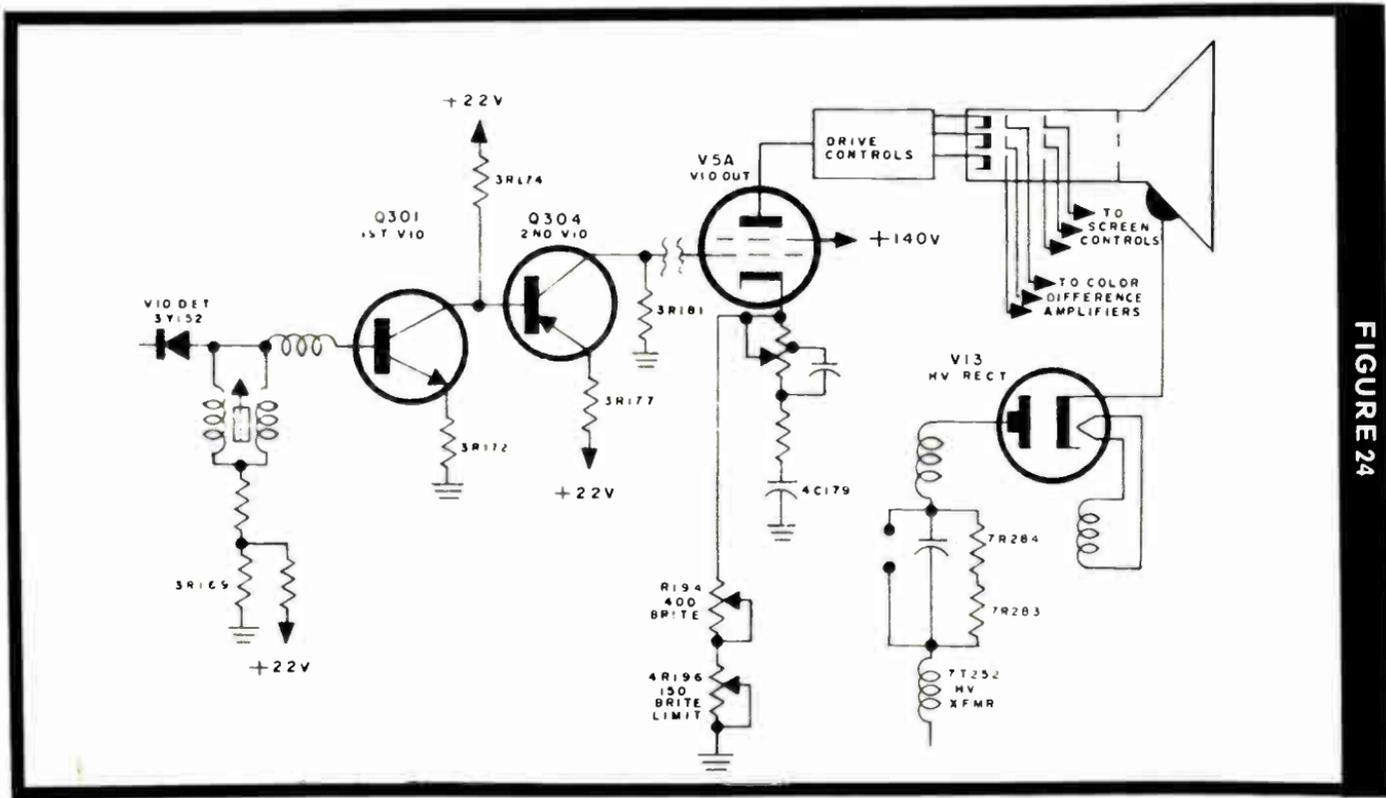
FIGURE 24

Blooming raster problems are normally associated with high voltage defects, but they can also be caused by excessive loading on the high voltage system. Refer to Fig. 24.

These excessive beam currents are the result of improper CRT element voltages—the bias voltage between the control grids and the cathodes being the most critical. The control grids are normally 100 to 150 volts negative with respect to the cathodes. (The actual voltages are determined by the brightness control.) If this grid-to-cathode bias should drop to 50 volts or less, heavy beam currents will flow.

A reduction in the grid-to-cathode bias is most likely caused by a decrease in cathode voltage relative to chassis ground. Since the video amplifier is DC coupled from the video detector to the CRT cathodes, any of the following defects could cause the CRT cathode voltages to decrease:

Should you service a C1 chassis with a focus tracking arc and raster bloom, be sure to check the CRT bias voltages. This will help you to determine whether the defect is in the high voltage circuit or in the video amplifier circuit.

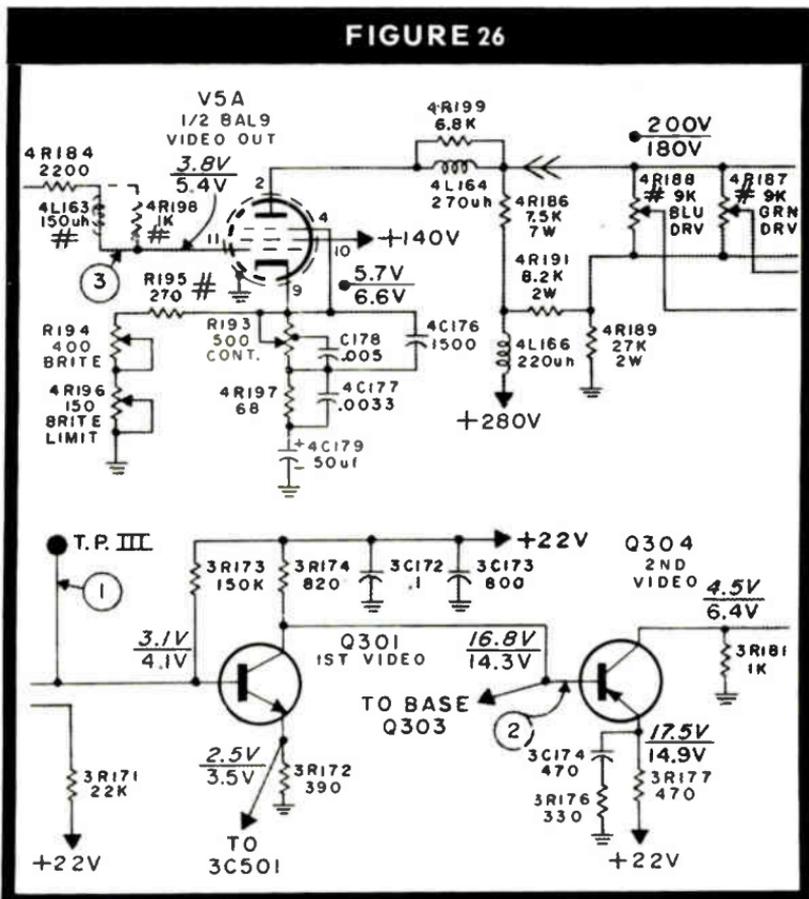
FIGURE 26

Arcing in the focus tracking network (Case History 26) may be due to a shorted 8AL9 (see Fig. 26) or capacitor 4C179. The contrast or brightness control wiring or a terminal may have become shorted to ground. Also, video transistors Q301 or Q304 may short and cause this same arcing. As with Case History 26, the result of any of the above troubles is excessive CRT beam current, which causes a heavy voltage drop across the focus tracking resistors.

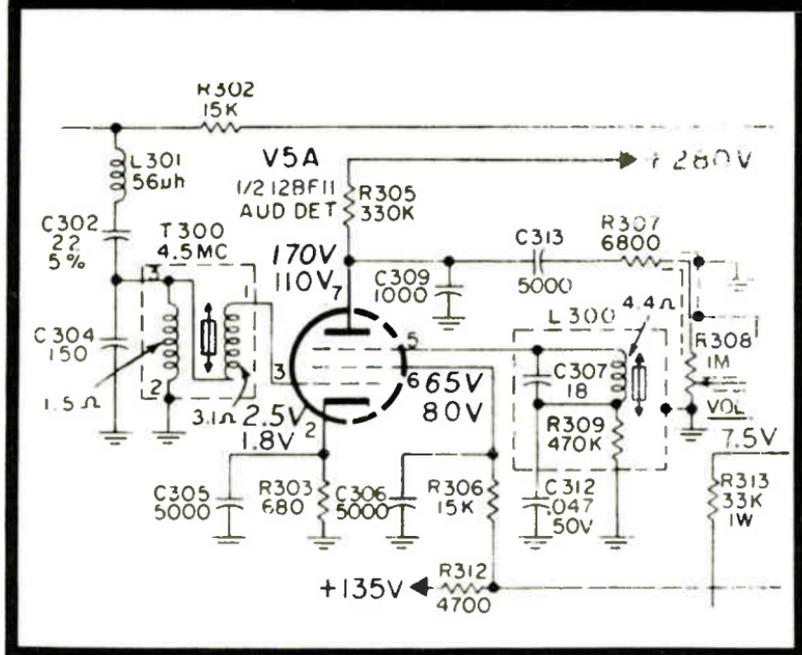
FIGURE 31

The sound on this color set drifted and became distorted after warmup. To eliminate the trouble, replace C307, shown in Fig. 31, with a GE part number ET18X399 capacitor only. This circuit requires a capacitor with a particular thermal characteristic (N470) to maintain correct alignment. Of course, make the sound alignment adjustments after installing the capacitor.

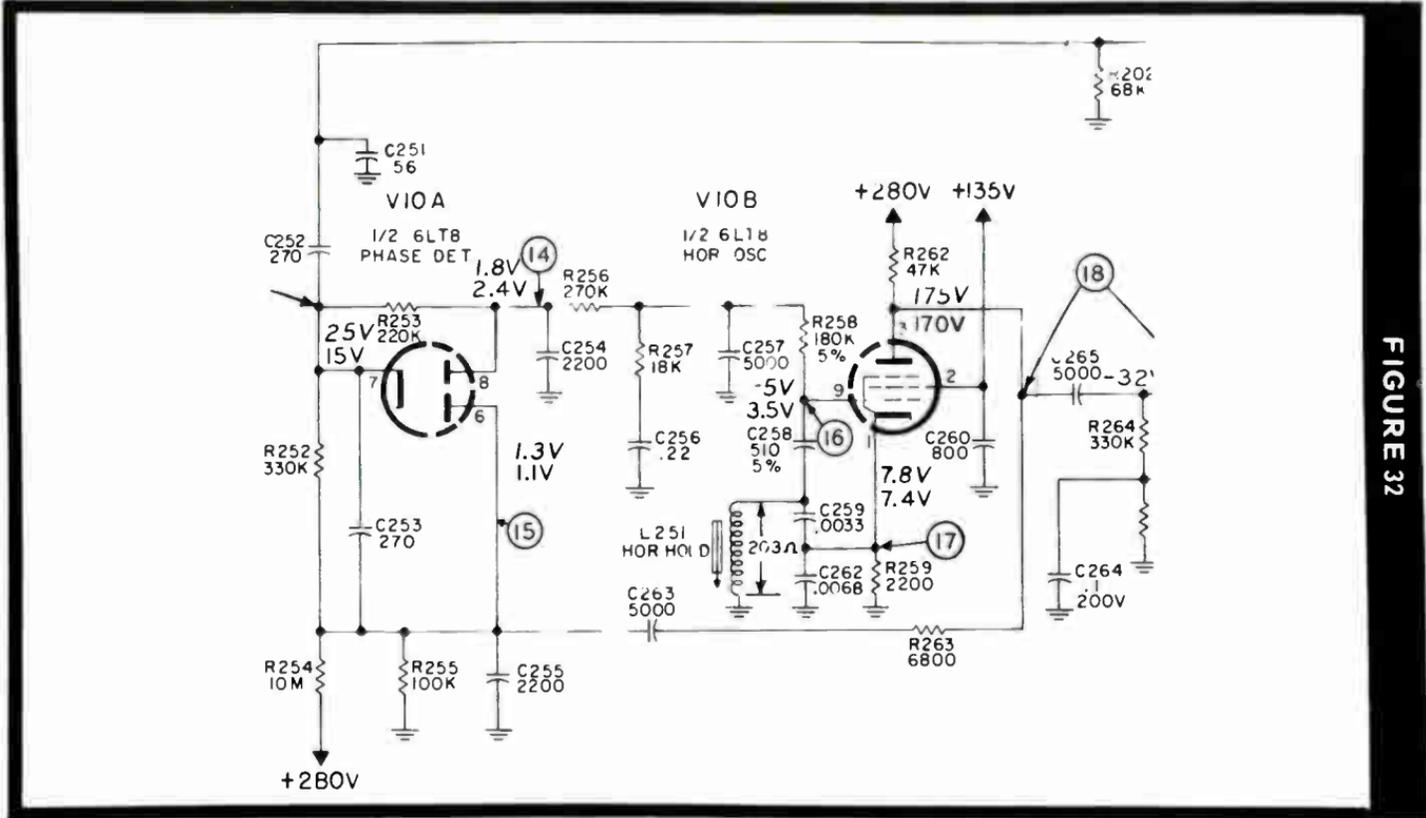
FIGURE 32

In this chassis, the horizontal oscillator started intermittently. The cause was found to be C258, a 510 pf capacitor. Use GE part number ET19X86. Refer to Fig. 32 for the horizontal oscillator circuit. Replace C258.

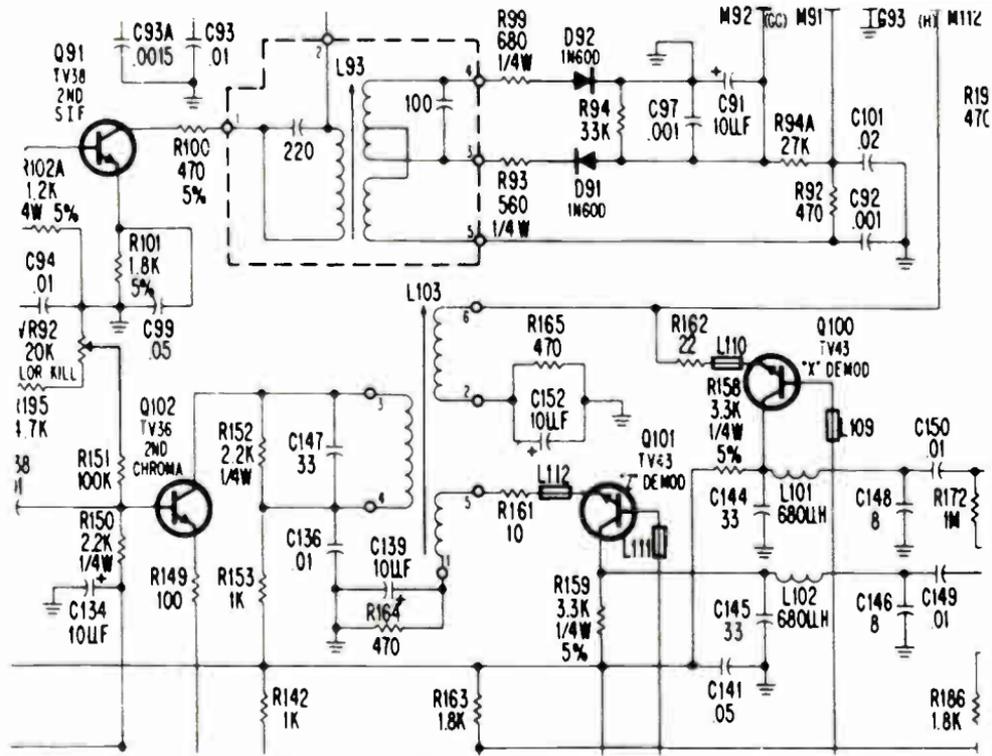
FIGURE 69

Another 20KT40 chassis had an odd color symptom. This set had color only on the left side of the raster when the chroma control level was turned up to a maximum setting. This half-color condition was caused by a defective Q102, the 2nd chroma transistor amplifier stage.

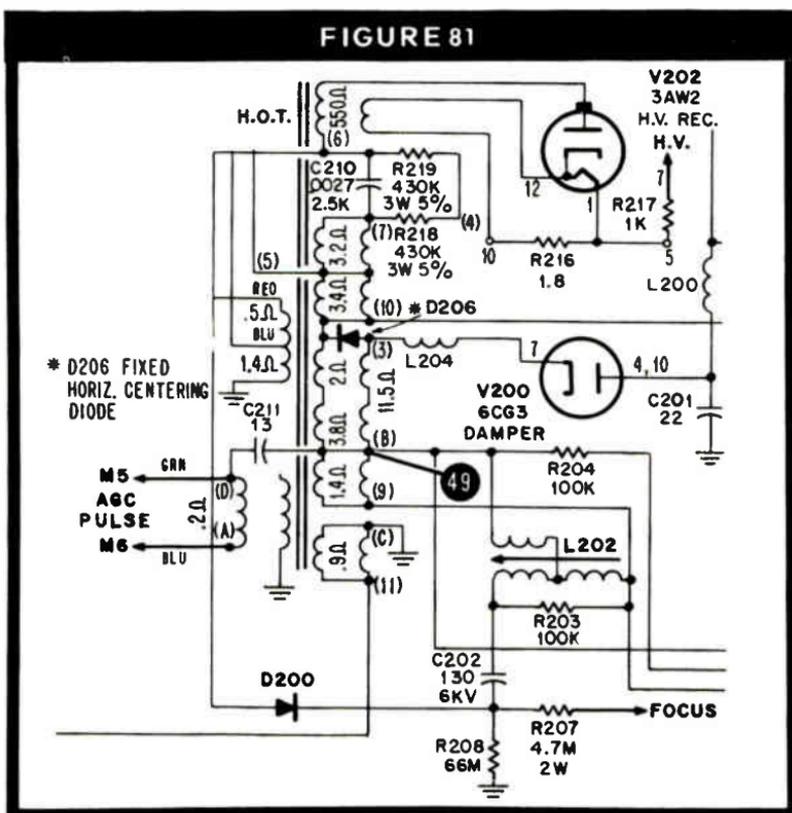
This picture shift condition was caused by a faulty horizontal centering diode, D206. This is shown in the horizontal sweep circuit of Fig. 81. If the picture is too far to the left, short out diode D206. However, do not remove D206 from the circuit. In some severe cases, install a 5 to 8 ohm resistor in parallel with diode D206, as this will help move the picture back to the right.

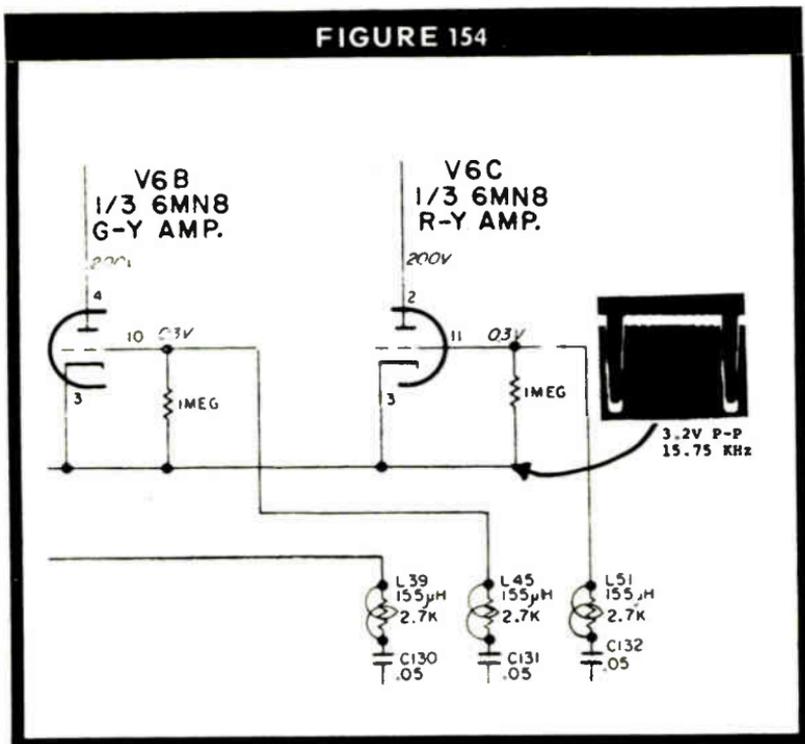
The possible cause: A faulty (shorted) capacitor C131 (.05 mfd) in the control grid circuit of the 6MN8 G-Y amplifier stage. This circuit is shown in Fig. 154.

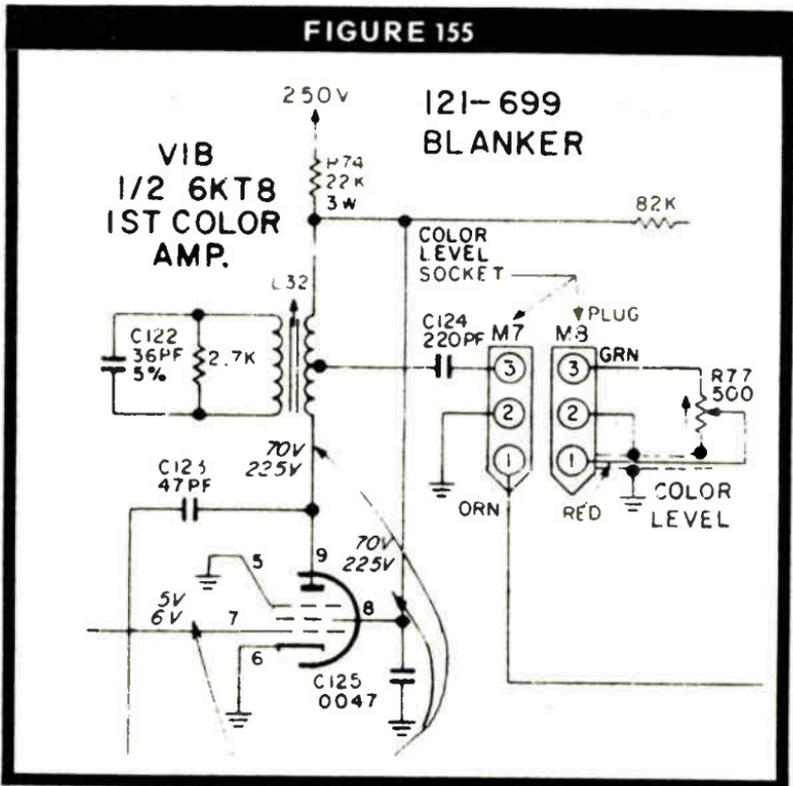
This color chassis, at first glance, looked like it had an open filter capacitor in the B+ power supply section. A scope was used to check the B+ supply, but all was found in good order. The screen produced a black horizontal hum bar approximately 4 inches wide that moved vertically through the raster. By using the oscilloscope, the trouble was tracked down in the color section. A defective (open) screen bypass capacitor, C125 (.0047 mfd), was located at V1B (Fig. 155) in the first color amplifier stage.

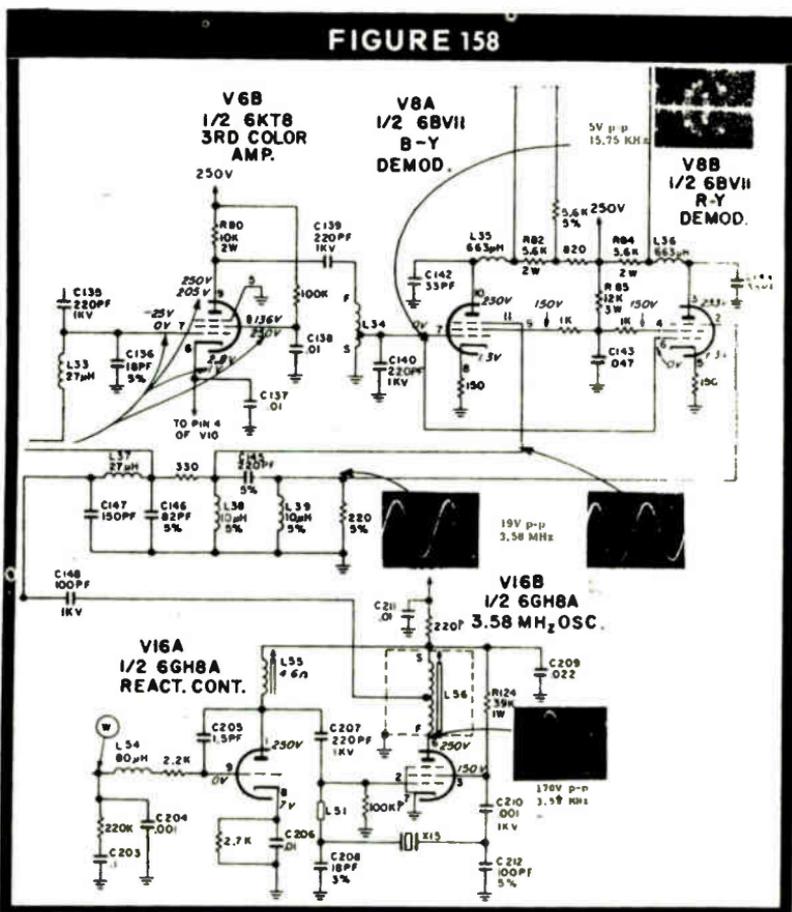
This phase shift condition was caused by a defective third color amplifier plate coil, shown as L34 in the schematic of Fig. 158. After this coil is replaced, check the set for proper color alignment.
