199 Color TV Troubles & Solutions

by R. L. Goodman

FIRST EDITION

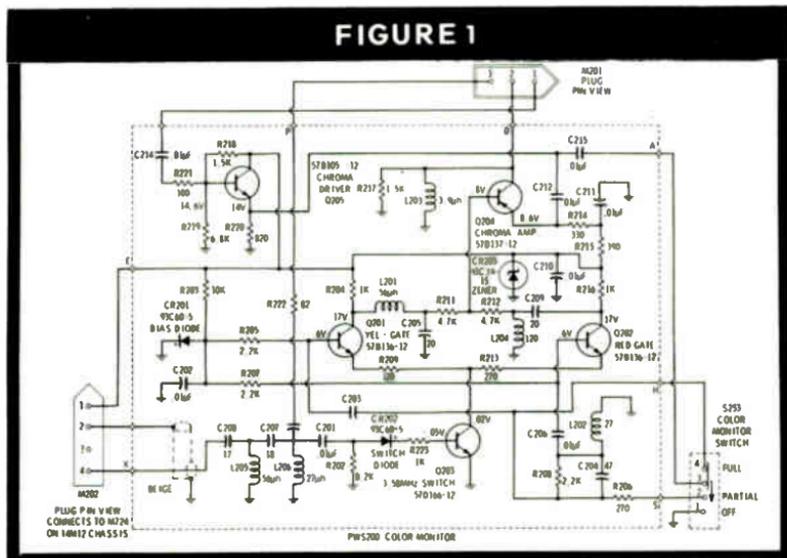
For the Admiral color chassis using the "color monitor" circuit (Fig. 1), which is a phase-control type circuit to improve flesh tones, complaints of no color may be due to a color-monitor circuit fault. The chroma signals go through the color-monitor chassis regardless of which position the switch is set in. Input is to pin 1 of the three-pin plug, through a .01-mfd capacitor to the base of the chroma driver transistor. The signal then goes to the color amplifier transistor, and thus to pin 2 of the plug.

Use your scope to check for the presence or absence of this color signal. Feed a color-bar signal into the antenna of the set and check for the amplitude of the "rocker" pattern on pins 1 and 2 of the plug socket combination. Use a demodulator probe, because this is an RF signal. Now, pull the plug from the color monitor chassis, and short pins 1 and 2 of the plug together. This will let the color information go onto the screen. If the chroma signal does not go through the color monitor circuitry, check the DC voltages, transistors, and all the diodes. Refer to the schematic for the correct DC voltages.

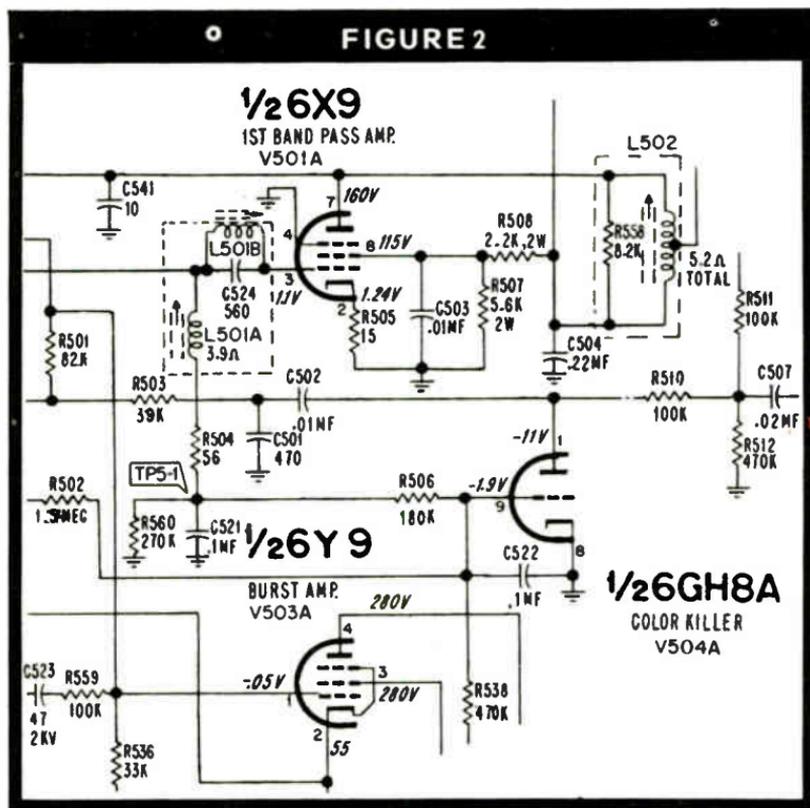
No color

We have repaired several of these G11 chassis that had this same symptom and circuit fault. The symptom may be no color or weak and intermittent color reception. Refer to the color killer schematic in Fig. 2 as to the possible component fault that will cause this lack of color. The defective part is C522, a .1 mfd capacitor in the grid circuit of V504A color killer stage. The failure of this capacitor causes a greater negative voltage to be produced at the grid (pin 9) of the color killer stage which will bias off the 2nd bandpass amplifier. Replace with a .1 mfd, 600 W.V.D.C. rated capacitor. Check and adjust color killer control R702 if needed.

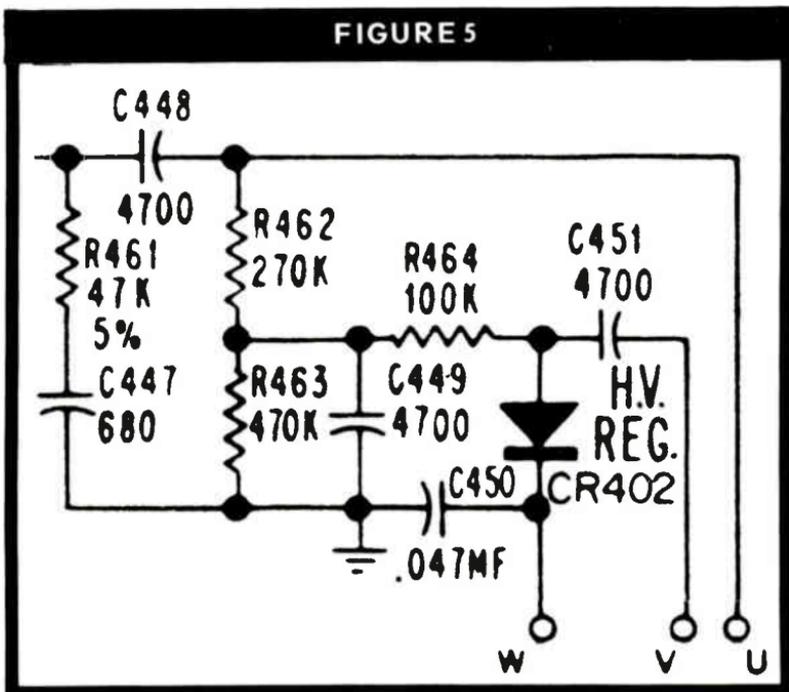
This color chassis HV control had no effect and the HV measured at more than 30 KV. It was also noted that the cathode current for the 6KD6 was excessive. A defective component was suspected in the regulator diode circuit shown in Fig. 5. Check for a negative voltage at the diode. It should be approximately -120v. The regulator diode can short or open, and may also become intermittent. Also, be on the lookout for poor solder connections to the PC board. Either case will cause excessive HV and current. Check for a shorted C449 or an open C451. The HV regulator diode must receive a pulse from a winding on the horizontal sweep transformer. Check the continuity of this winding. If found defective, replace regulator diode (CR402) with Part No. 93B60-3 and capacitor C449 (.01 mfd).

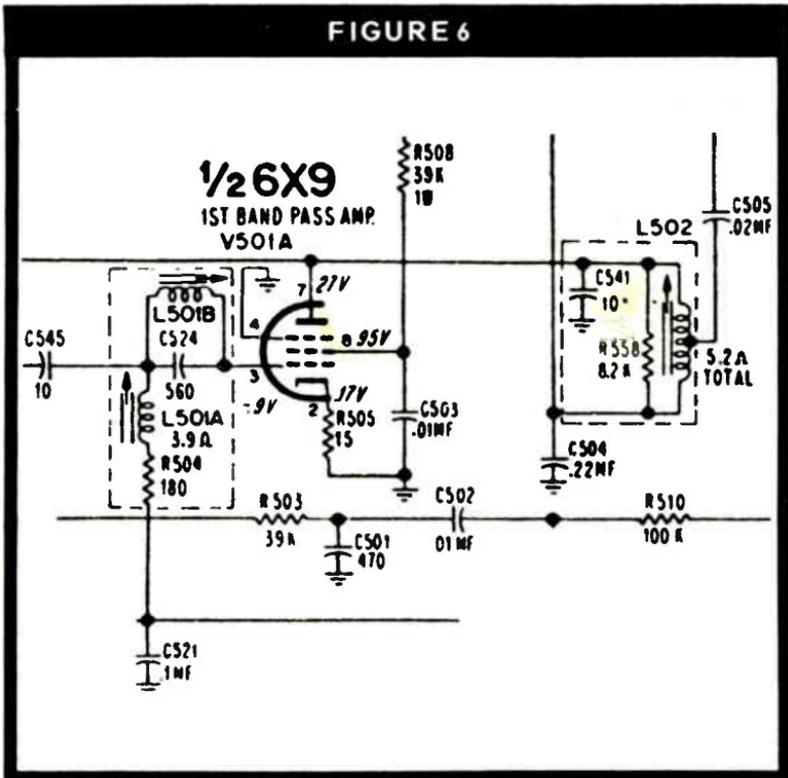
Weak or no color

Replace defective capacitor C521. This .1 mfd capacitor may check out good with an ohmmeter. The voltage from the killer stage is biasing off the control grid of the second bandpass amplifier stage. If the screen voltage on the first color bandpass amplifier is low and does not change when the tube is removed, check for a faulty C503 capacitor. This may be a green disc capacitor and is very likely to fail when used for this circuit application. Replace the .01 mfd disc capacitor. Note schematic in Fig. 6.

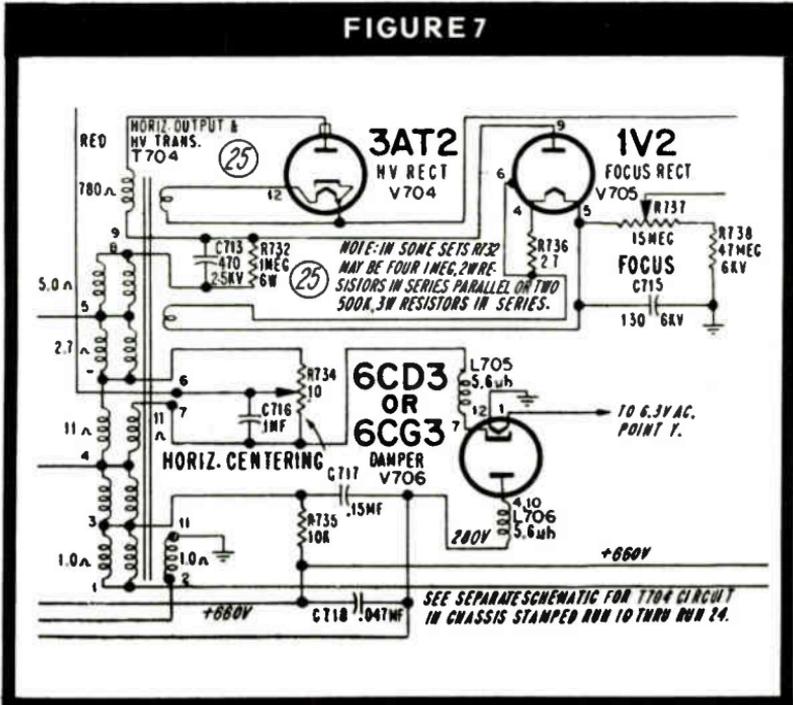
No picture

This chassis came into the shop with no picture (black screen) and the HV measured zero. The trouble appeared to be in the horizontal sweep output section. Many voltage checks and tests were made before we found this defect. Finally, a defective horizontal centering control was discovered. This is a 10-ohm control shown as R734 in the horizontal sweep circuit of Fig. 7. This control may also be burnt, but you can smell this trouble. In some chassis this control will be defective, but you will have high voltage with only a thin, bright vertical line in the center of the screen. Replace the horizontal centering control (R734) and check for correct HV at the CRT anode.

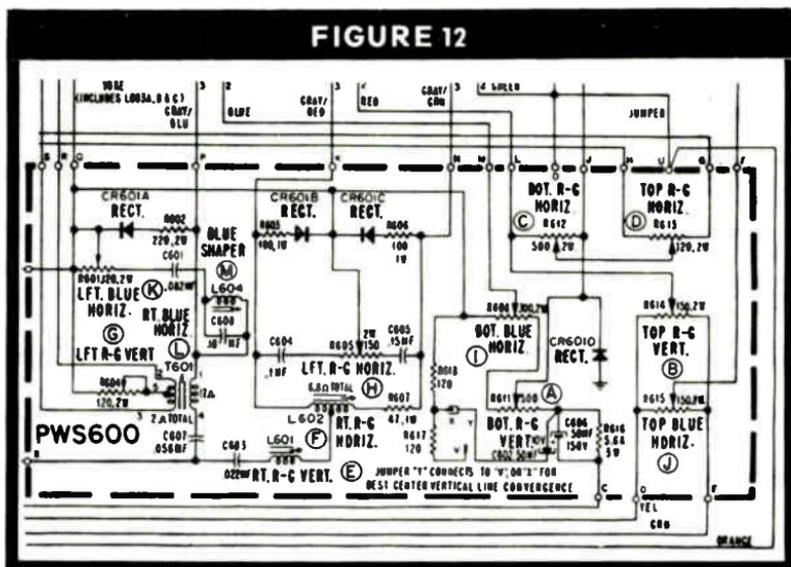
On some chassis, T601 and R601, have overheated. Both components are located on the convergence panel (Fig. 12). In later production, R601 has been changed from (120 ohms, 2 watts) to (120 ohms, 3 watts), and a 30-ohm resistor, R619, added in series with R601. For field service replacement, use the 120-ohm, 3-watt unit and add the 30-ohm, 5-watt resistor in series with either side of R601 by cutting the foil and mounting the resistor on the foil side of the PC board.

If R601 or T601 overheats, check the adjustment of the blue shaper coil. Remember that the blue shaper coil is not a convergence adjustment and must be set according to the manufacturers instructions. Should it be necessary to change T601 or the other coils on this board, be sure to use correct replacement coils. The 93D175 and 94D305 part numbers have been used. Because the basic configuration of the coils is different, they cannot be interchanged.

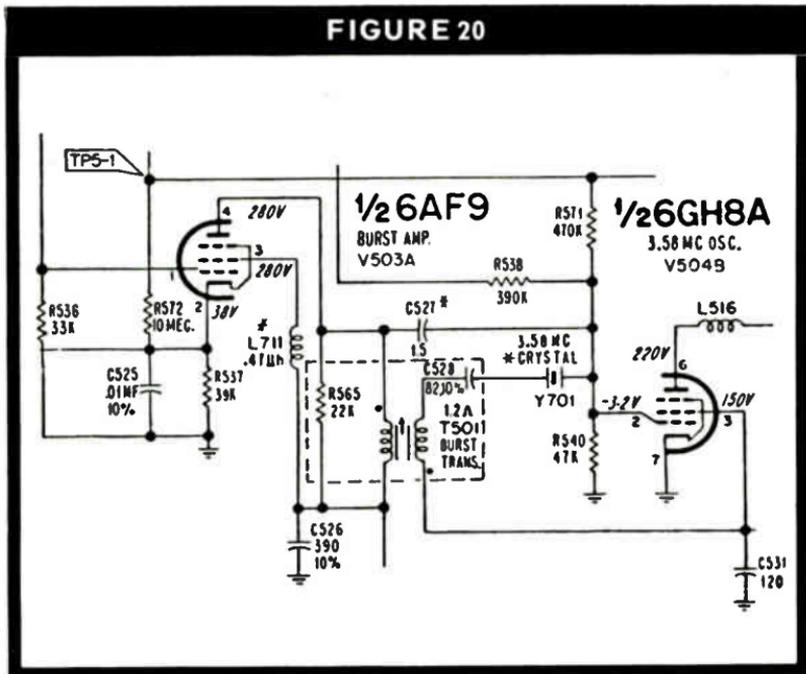
The color sync on this chassis was erratic, and when switching from channel to channel the problem appeared intermittently. The set had a clear black and white picture with good audio. We suspected a cold solder joint in the burst amplifier or color oscillator circuit board section. When the color burst transformer was moved we noted that the trouble would appear. After some more detective work, the problem was located inside the T501 burst transformer can. Capacitors C527 and C528 in the burst transformer were defective. Notice the color burst system schematic shown in Fig. 20. You may want to replace the complete transformer unit.

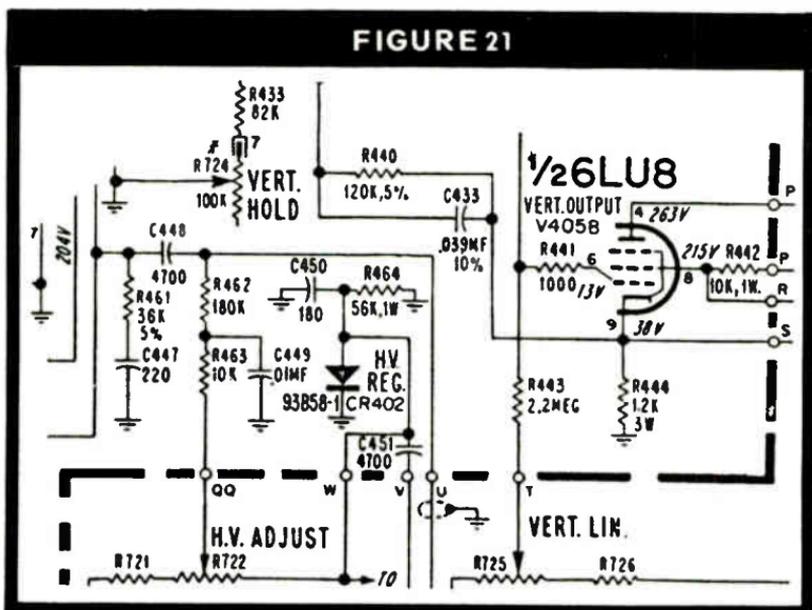
FIGURE 21

No HV control

Everything seemed to be working normally in this chassis, but the high voltage was excessive. There was very little HV regulation and the HV adjust control had no effect. The CRT anode voltage measured over 30KV and the cathode current of the 6KD6 was excessive. We now looked for a defective component in the regulator diode circuit shown in the schematic of Fig. 21. There should be a negative voltage at diode CR402, approximately -120 volts. The regulator diode may short out or open up. Either of these conditions will cause excessive HV and H.O.T. cathode current. Also, check for a shorted C449 (.01 mfd) or open C451. The diode must receive a horizontal gating pulse from a winding of the sweep transformer. Use your scope to check for the presence of this gating pulse. If the diode is defective, replace it with Admiral part number 93B60-3.

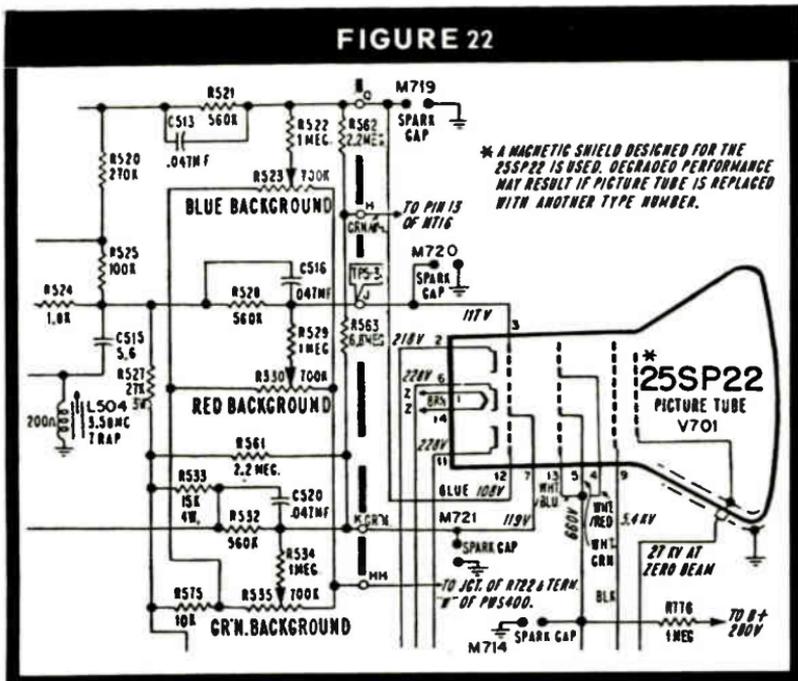
The left side of the raster on this set had become almost a solid, single color and looked like a purity problem. A faint, wide vertical bar may also be noticeable in the raster. Moving the grid leads to the picture tube would change the intensity on the left side of the raster.

Use the schematic in Fig. 22 and the following tips to locate this trouble. Look for an open C513, C516 or C520 (.047 mfd) capacitors. The color of the vertical bar or shading will indicate which capacitor. For example, C520 would produce green, etc. Also, checking the individual fields will reveal which color is affected.

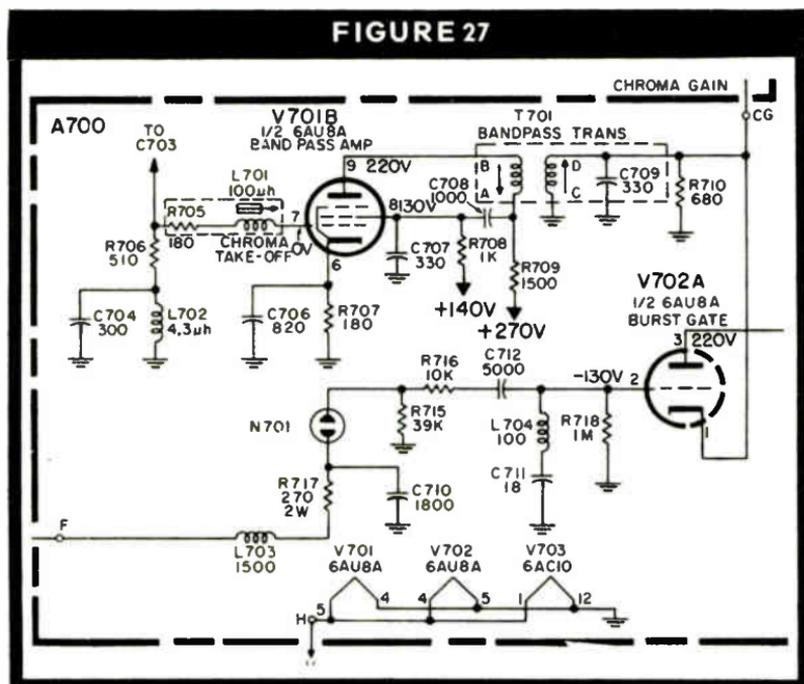
This GE color set had a good black-and-white picture, but there was no color at all. In this chassis the color burst signal rings the 3.58-MHz crystal and there is no color killer circuit or control. The color circuits for this set are shown in Fig. 27.

The oscilloscope was used to probe for incorrect waveshapes in the color stages and it was noticed that the burst was missing at pin 3 (plate of V702A) the color burst gate stage. Also, the horizontal keying pulse was not found at the grid (pin 2) of this same tube. A few more checks revealed that C712, a ceramic 5000-pf capacitor, had opened, thus accounting for the missing horizontal keying pulse. It is also a good practice to replace the neon bulb (N701) in these chassis, should you have a color reception problem. The color looked good after installing C712 and the neon bulb.

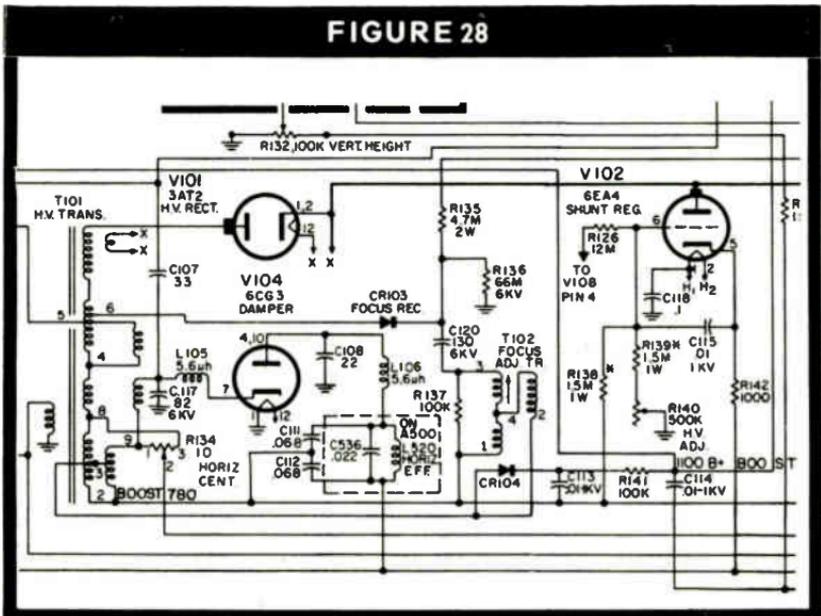
The brightness control would not extinguish the raster on this set's CRT. However, the contrast control operated a little like the brightness control should. The screen of the CRT was dull, washed out, with retrace lines and very blurred. None of the screen controls had any effect on the picture setup or CRT brightness level.

This problem was caused by the B boost lead wire (the circuit that feeds 1100 volts B boost to one side of the screen controls) being shorted to pin 7, cathode, of the damper tube V104. (Notice the horizontal sweep circuit in Fig. 28.) This was, in essence, putting a high horizontal pulse voltage to the CRT screen controls. This short circuit also burnt up R141, a 100K boost filter resistor, and ruined boost diode CR104.

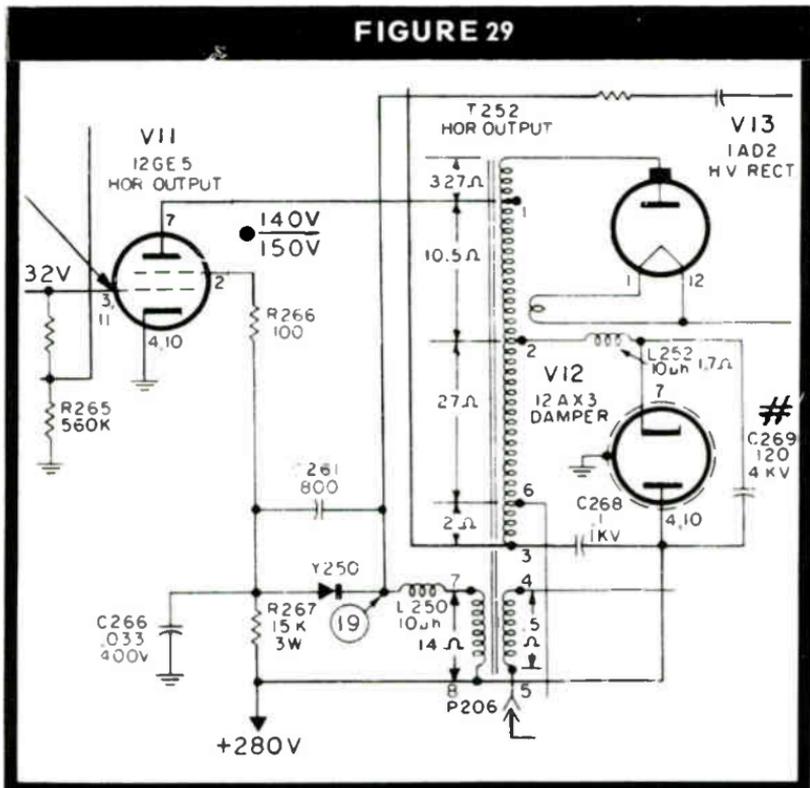
GENERAL ELECTRIC H3 CHASSIS No raster, no high voltage

Check C266 (.033 mfd) for a short or a leakage condition. (The schematic is shown in Fig. 29.) Also verify that R267 has neither changed in value nor desoldered itself as a result of the heat caused by the C266 short. The resistor may have heated up sufficiently to cause the solder to flow from its leads. Also check V11, the horizontal output tube.

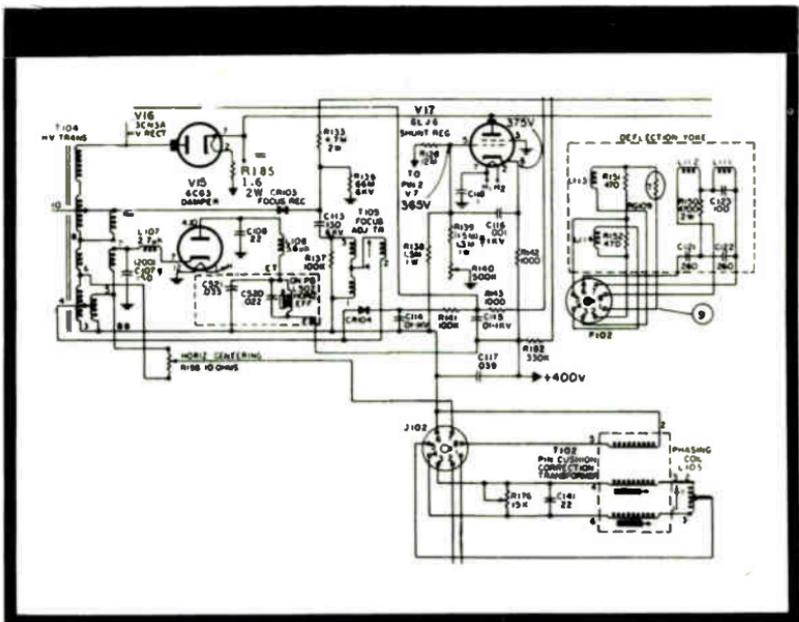
Trouble is due to a low heater voltage on the 6CG3 damper tube. (In some cases, it checked out at 5 volts.) This low heater voltage is due to a poor contact at the riveted ground or terminal board 2 which carries the heater ground return from pin 12 of the damper.

Adding a length of bus wire from the ground lug of the terminal board to the nearest solder "lance" on the chassis should solve this width problem. Be sure that you get a good soldered joint.

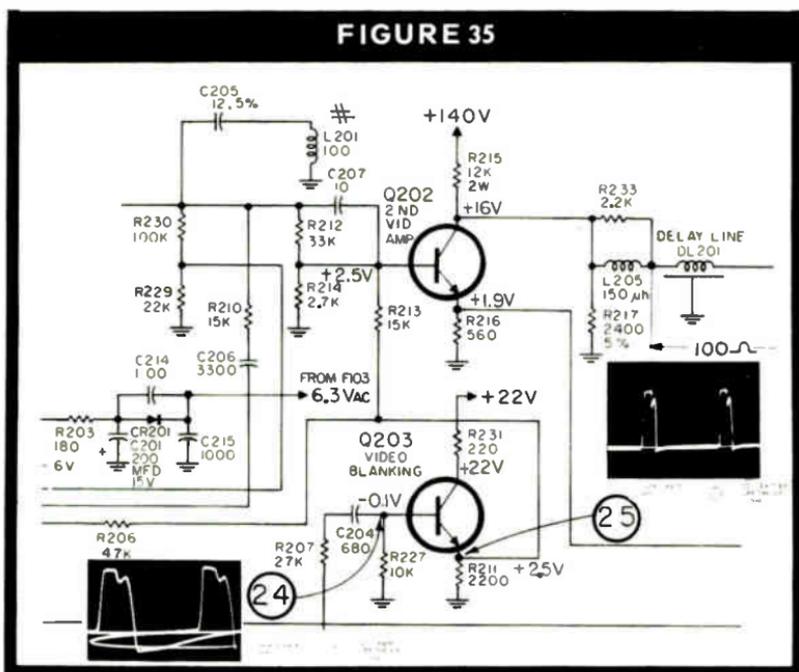
A vertical rainbow stripe of red, green and blue appeared about one-third of the way in from the left-hand side of the screen. The stripe is more visible at low contrast and can occur on both monochrome and color. The horizontal hold control will move the stripe to the left or right.

Probable cause is a fault in the retrace blanking circuit. It may be due to a defective Q203 or some other component in the blanking circuit. Check the voltages at Q203 shown in the schematic of Fig. 35 and use your scope to check for correct waveforms shown at numbers 24 and 25. Notice that the voltage shown at the emitter of Q203 is 2.5 volts.

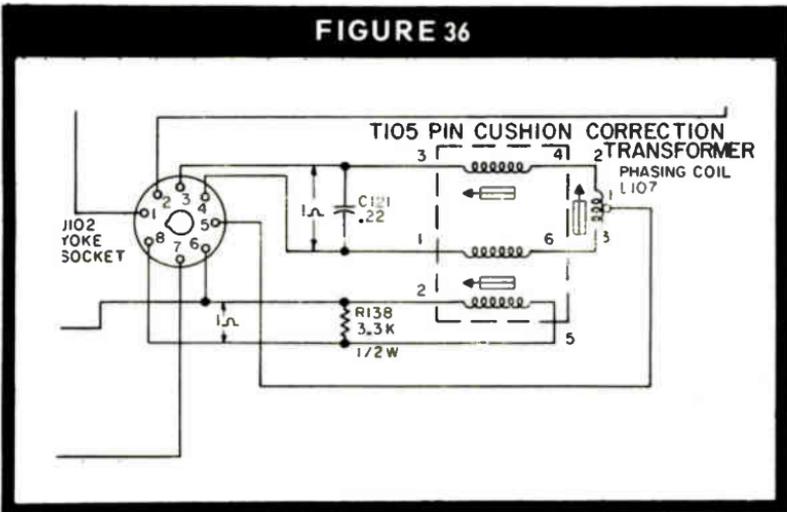
This GE color set had insufficient vertical picture size, plus vertical retrace lines appeared across the screen. The vertical sweep stages were checked out and no trouble was found.

After a few more checks, the fault was found in T105, the pincushion correction transformer which is shown in Fig. 36. The winding was open between pins 3 and 4. This same trouble has been found in other color chassis.

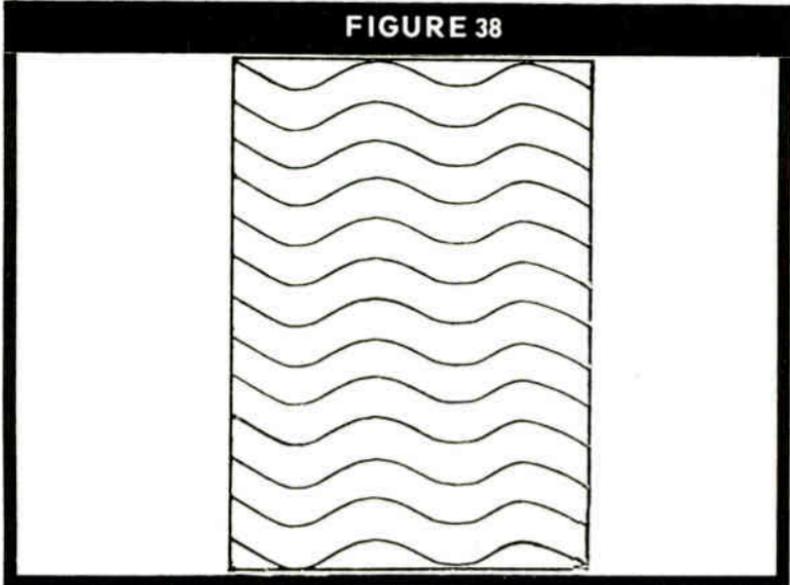
FIGURE 38

In some reception areas, you may encounter an interference problem which produces a beat pattern as shown in Fig. 38. It is usually found when using "Rabbit Ears" or when an unbalanced condition exists in the antenna or CATV system.

Correction: Add a 20 pf Hi Q ceramic capacitor on the bottom of the main circuit board as follows: Using the shortest possible leads, connect the capacitor from the chroma gain control end of L725 at the wire wrap terminal to the nearest solder point on the copper ground plane.

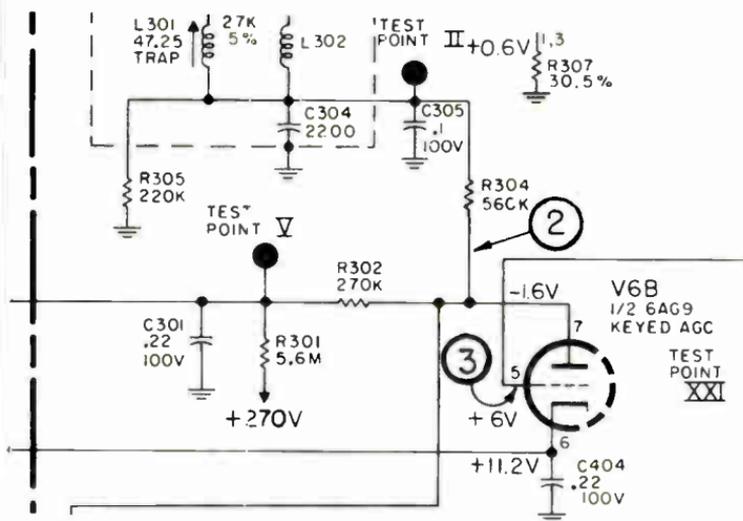
FIGURE 41

A faulty capacitor may cause double-trouble in some of these GE KE receivers. Refer to the schematic in Fig. 41.

Another chassis displayed a bending-pulling picture and had a very loose sync-lock condition. And again, C305 was found to be defective, but this one was now open. The last condition seems to be rare.

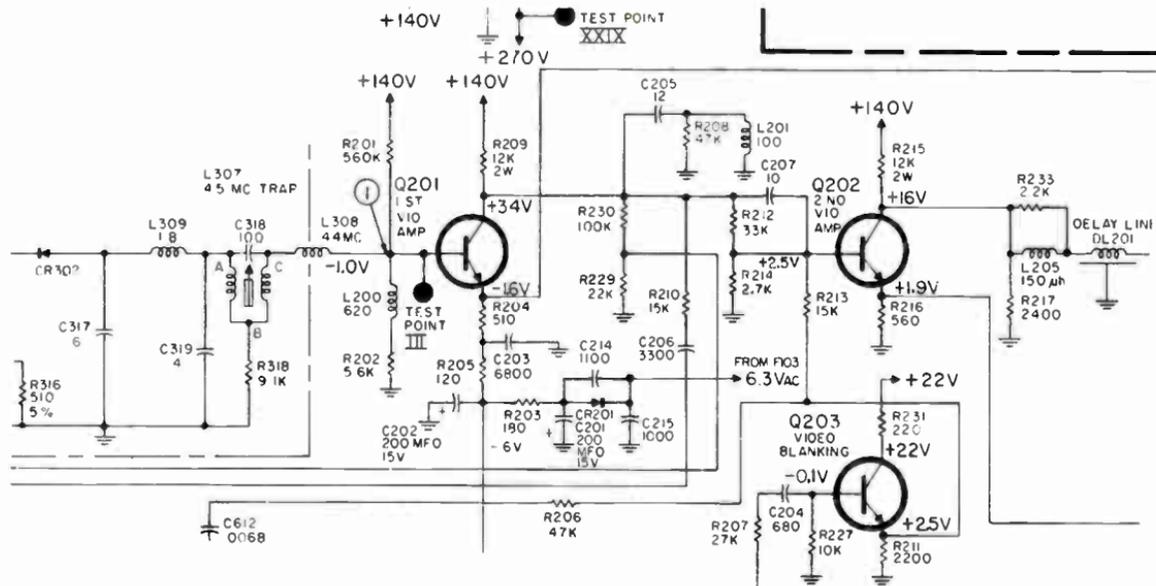
FIGURE 42

The causes of the following video troubles appear on the schematic in Fig. 42:

No video or weak, washed-out video. Transistor Q202 is defective.

No video or audio and possibly some vertical retrace lines. The 200 mfd filter capacitor, C202, has shorted.

Blank screen, no video. Faulty Q201 transistor.

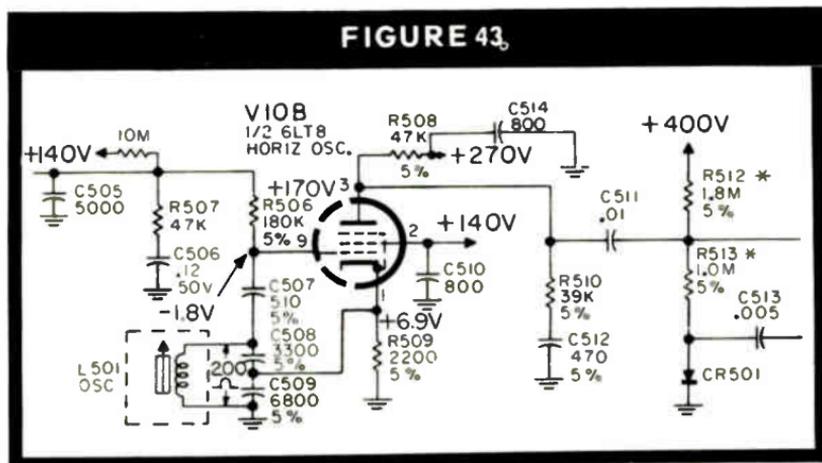
The horizontal oscillator was found to be off frequency in this color set. If the oscillator is far enough off frequency the horizontal output tube will overheat and no high-voltage would be developed. The trouble was found to be a faulty 510 pf capacitor (C507) in the horizontal oscillator circuit shown in Fig. 43.

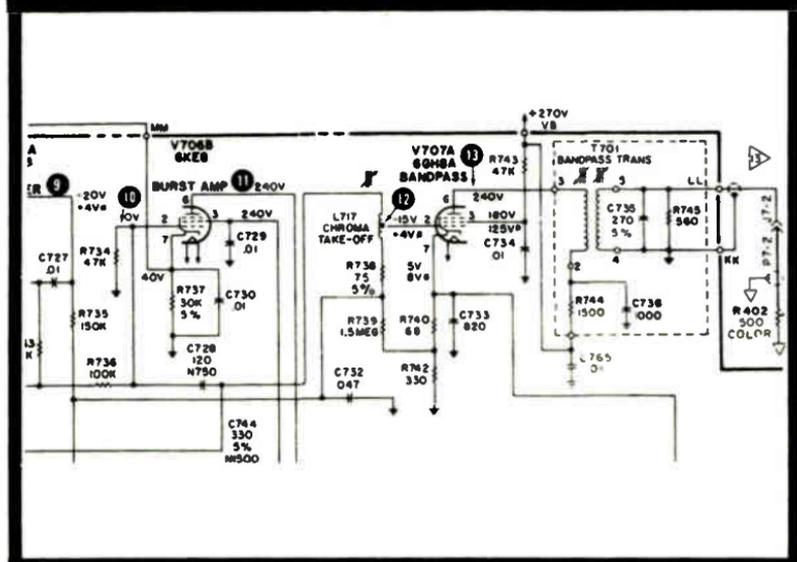
FIGURE 46

This set had critical color sync, depending on the setting of the hue control, and adjusting the reactance coil would cause it to lose sync and color completely. Tubes and diodes checked good. The cathode voltage on the burst amplifier (V706B) was the key measurement, as it was about 15v DC instead of the usual 40-50v as shown in the schematic of Fig. 46. The scope showed a severe distortion of the burst signal at the plate and an amplitude of 7v p-p instead of the normal 100v p-p. The fault was an open .01 mfd capacitor (C730) in the burst amplifier circuit. With this capacitor open, degeneration in the cathode circuit made the burst amplifier ineffective and there was not enough burst signal to provide any color sync.

Another T933 chassis had what looked like phase detector troubles. The entire screen had a tint which could be varied (blue, magenta to red) by adjusting the hue control and could be eliminated by turning the chroma control down. This condition only showed up when a color program was being received. The set was checked with a color bar generator and the bars on the right side of the screen showed little of the correct colors. Instead, they assumed the overall raster tint. This test proved that the color signal which did get through was in color sync and the hue control could vary the colors of the bars. Using a scope to trace this color signal through the chroma circuits revealed a rather husky horizontal pulse on the grid of the bandpass amplifier, V707A. Again refer to Fig. 46. The plate of the color killer stage is coupled to the grid of

the bandpass amplifier to cut off this stage when a B&W signal is received. The color killer uses a horizontal pulse as its plate voltage source (like a keyed AGC stage) but there is a .047 mfd capacitor (C732) in the bandpass grid that will by-pass to ground any horizontal pulse present there. In this case, C732 was found to be open.

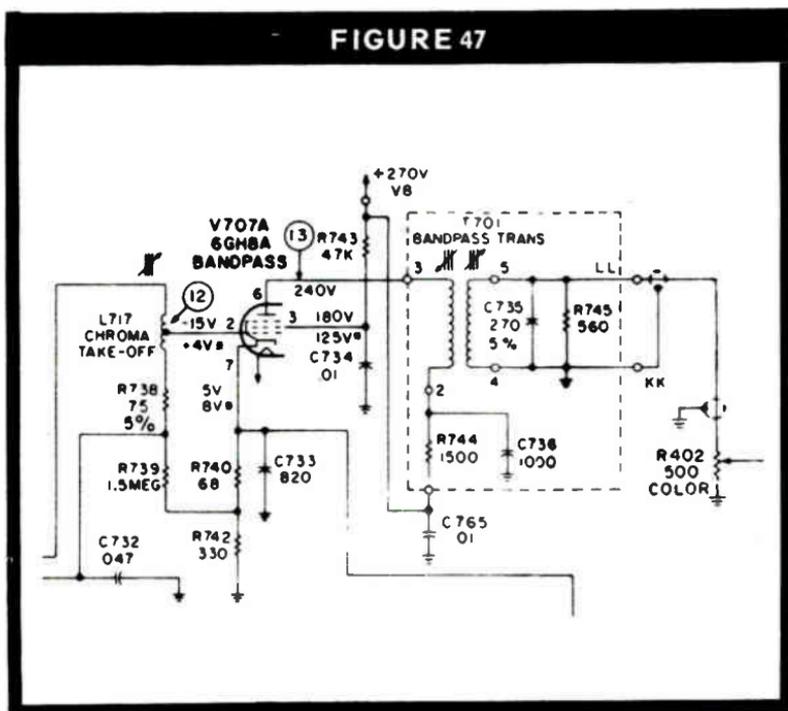
FIGURE 47

This set had a good black-and-white picture, but the color was weak. No trouble was found in the antenna system and all tubes checked out good. On the service bench the scope was used to trace the chroma signal through the color amplifier stages. The scope found a very low p-p chroma signal at pin 6, plate of V707A, color bandpass amplifier, shown in the schematic of Fig. 47. A few more checks in this circuit revealed that screen bypass capacitor C734 had shorted and caused R743 to burn. We replaced C734, a .01 mfd, and R743, a 47K resistor, and the set had good strong color.

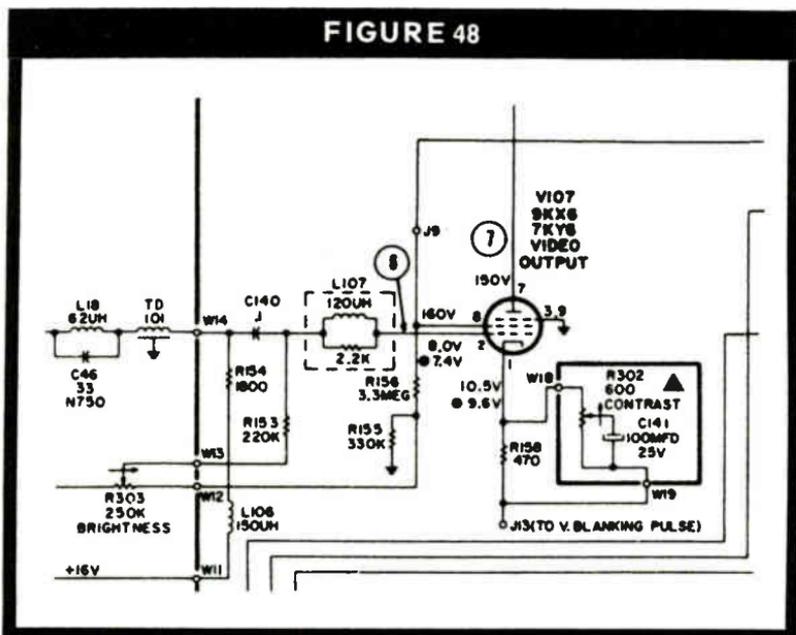
FIGURE 48

The weak video showing on the screen of this set looked like we had a weak CRT. However, the picture tube checked out very good on this small screen color TV receiver. The DC voltages on the 9KX6 (shown in the video output schematic of Fig. 48) were measured and found to be very close to normal. An oscilloscope was used to trace the video signal through all of the video amplifier stages. We found the proper video amplitude signal at the grid (pin 2) of V107, but a very low amplitude on the plate (pin 7). The trouble was found to be an open 100 mfd capacitor in the cathode circuit of V107. After C141 was replaced, the set produced a good picture with lots of contrast.

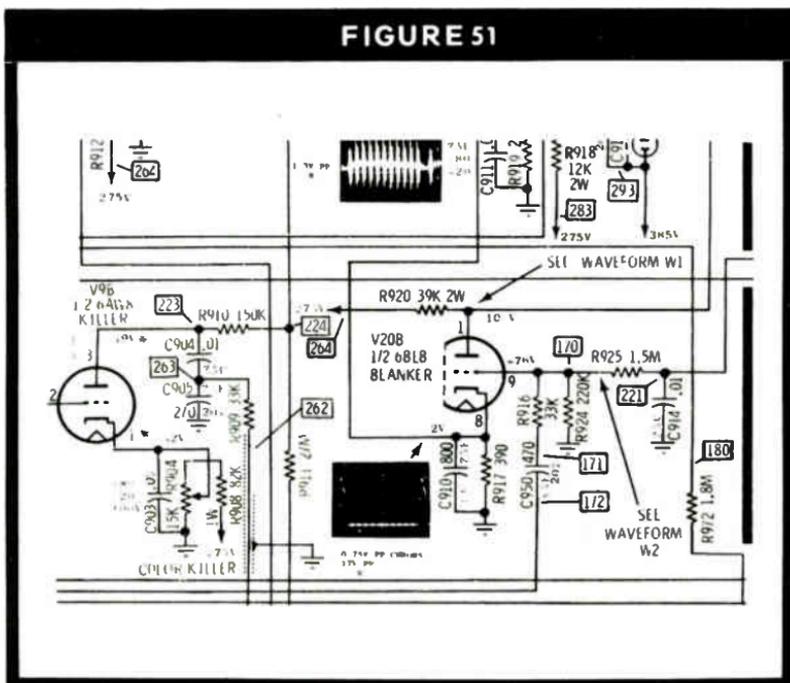
FIGURE 51

This color receiver produced good audio; however, the screen had insufficient brightness. The CRT and the high voltage checked out good. Some checks were made in the video stages, but no circuit faults were found. The defect was located in the blanking amplifier circuit shown in Fig. 51. The plate resistor of V20B was found to be open. This open resistor, R920 (39K, 2 watt), lowered the plate voltage on pin 1 of the 6BL6 blanker tube. This same symptom can be caused by an open C917, .1 mfd capacitor not shown in the schematics, also, in the plate circuit of V20B. Don't overlook a faulty (weak) 6BL6 blanker tube.

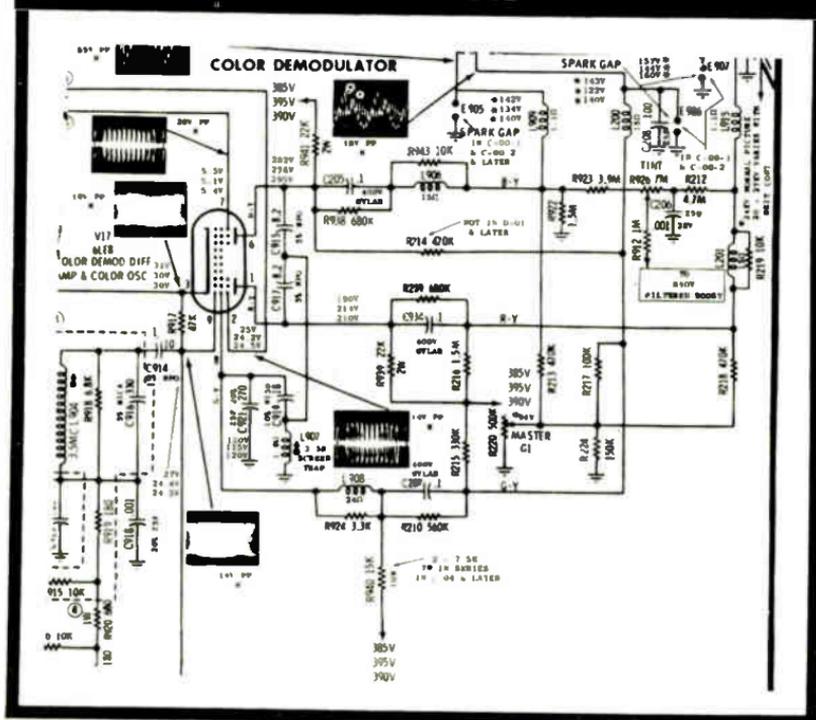
FIGURE 52

On early run chassis, it was possible to adjust the brightness so high as to exceed the power handling ability of the HV rectifier tube (3AT2). Beginning with TS914A-05 chassis run, the brightness range was restricted by removing B+ (385 volts) from the top end of the master G1 control and connecting a 47K resistor from control arm to ground. On these chassis, if more brightness is required, first try a new 6LY8 video tube. If this does not help, resistor R224 can be changed from 47K to 150K. Later production chassis now use 150K resistor as shown in Fig. 52.

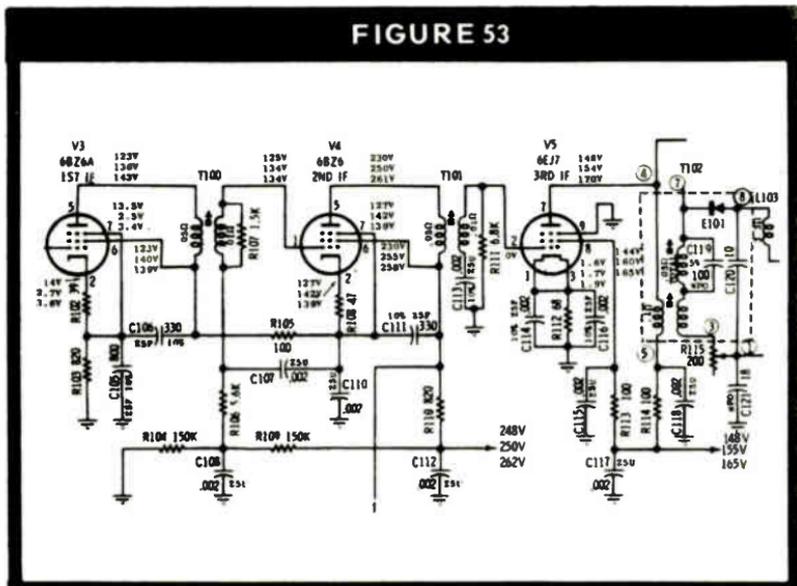
FIGURE 53

This set had good sound but no picture, just a blank white screen. The HV and brightness were normal. Voltage checks were not of any help for this trouble. The fault for this symptom was located in the video IF section that is shown in Fig. 53. This (no video) condition is caused by an open 200-ohm control (R115) located in the T102 transformer circuit. For a quick check, just jump a test lead across the control. Replace R115 control and check the IF alignment.

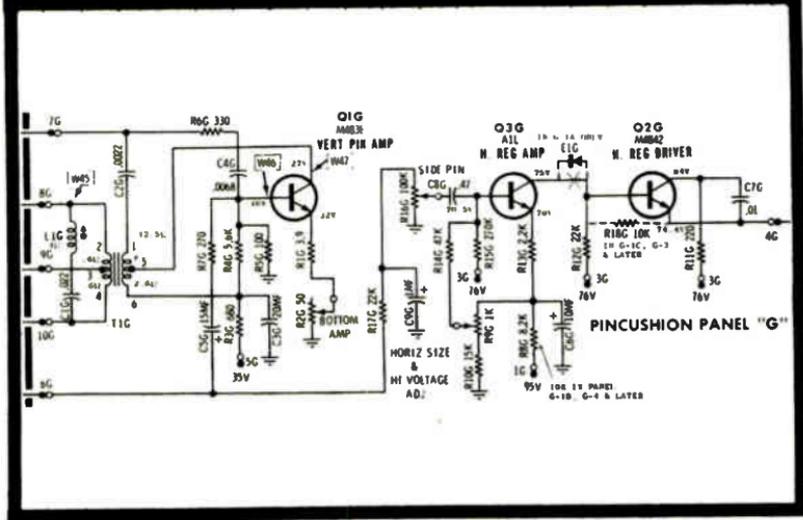
FIGURE 62

In this solid-state chassis we had good sound and a picture, but it was very narrow. The first section to be checked was the power supply and then the horizontal sweep circuits. However, these systems were all found to be in good order. After looking at Motorola's trouble chart, we checked pincushion panel "G." This panel is shown in the Fig. 62 schematic. This narrow picture was caused by a defective 10 mfd capacitor located in the emitter circuit of Q3G, the horizontal regulator amplifier transistor. Replace C6G.

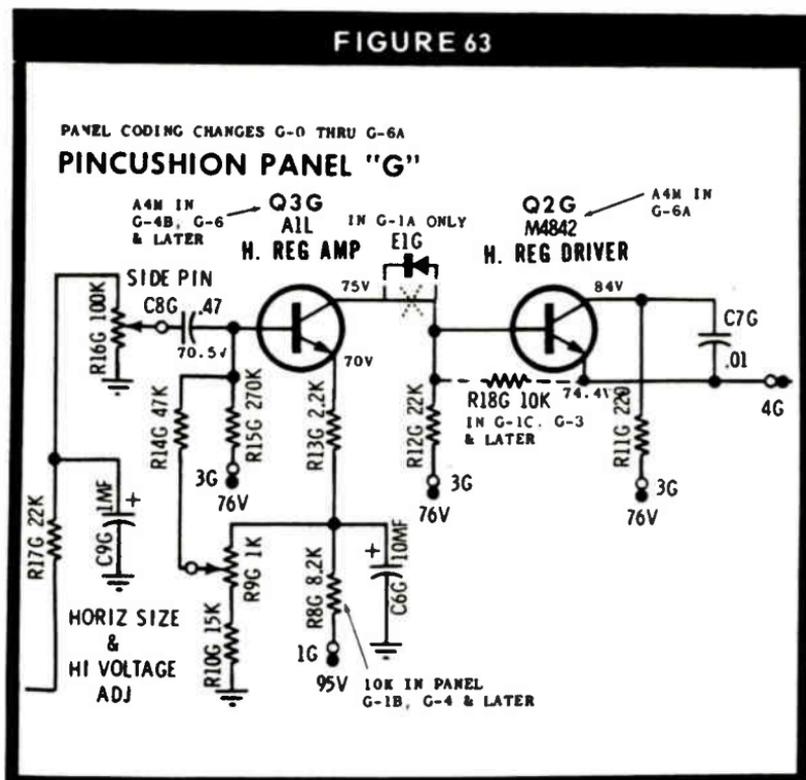
FIGURE 63

This set did not produce any picture and no HV was found at the CRT anode lead connection. No trouble could be found in the horizontal sweep and HV section. A complete check of the power supply and low-voltage system revealed no faults. After a new pincushion panel "G" was installed, the picture and HV were restored. We then started troubleshooting the "G" panel. The fault was an open resistor in the emitter circuit of Q2G, the horizontal regulator driver transistor. Replace R11G, a 220-ohm resistor shown in Fig. 63.

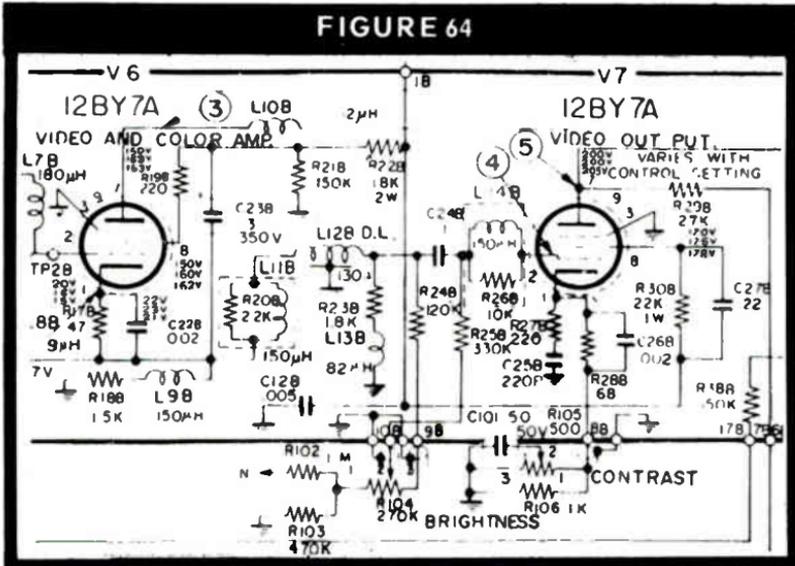
FIGURE 64

This receiver had good sound, but a poor focus condition. At least that's what it appeared to be. A closer observation revealed that the raster had sharp focus, but the degraded video information displayed on the screen was due to poor resolution.

This poor resolution problem may be caused by several different circuit faults. Use these following suggestions for a check list. See the video circuit in Fig. 64 as you go through this list.

1. Check for a too-narrow bandwidth in the IF amplifier section.
2. The detector load resistor may have increased in value.
3. Check for a faulty R31B resistor (not shown) video peaking coils, and delay line, L128.
4. Check all voltages on the V6 and V7.
5. Measure all video amplifier tube (V6 and V7) load resistors.
6. Of course, make a complete IF sweep alignment check.

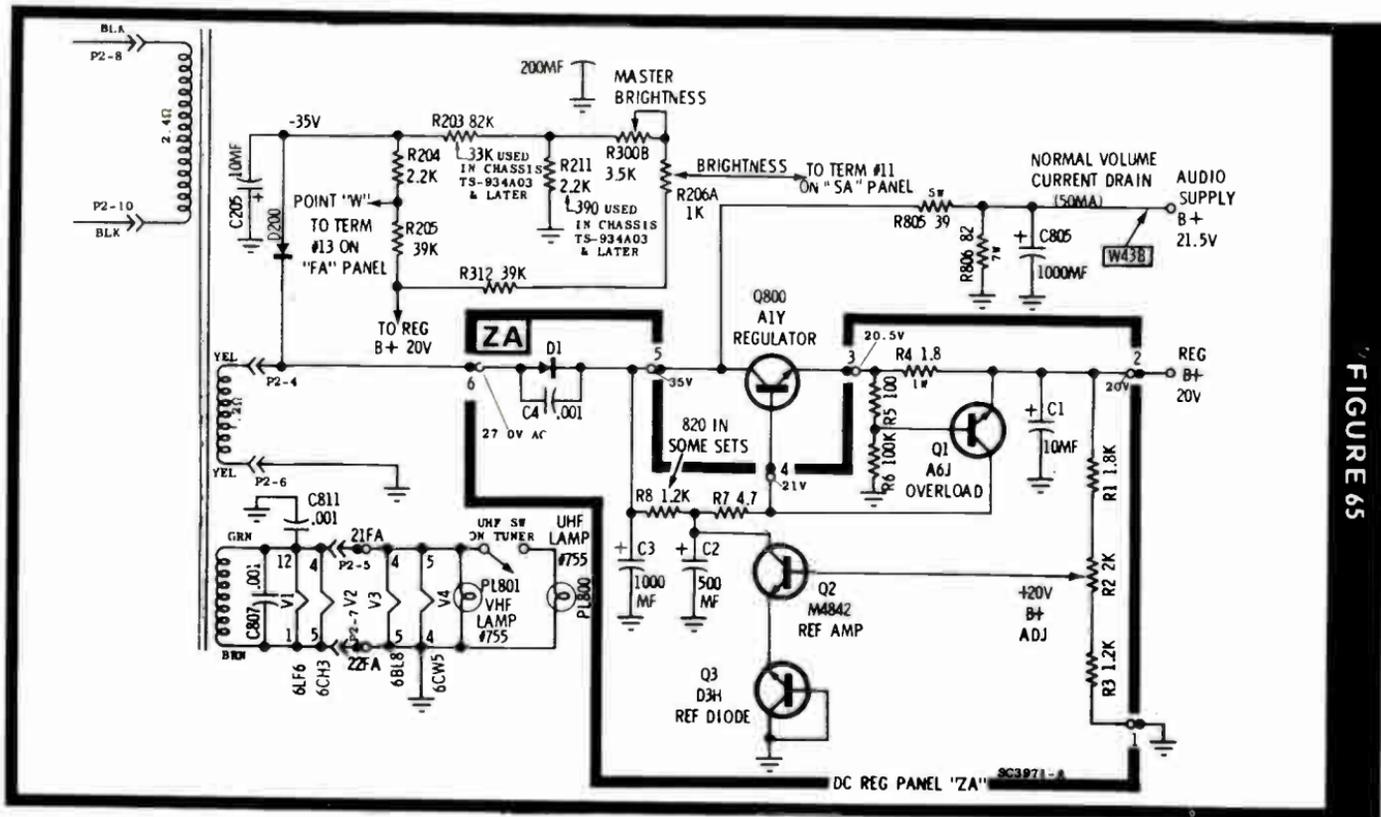
FIGURE 65

Many of these Motorola Quasar II Color Chassis develop the same picture symptom, but more than one fault will cause this trouble. The picture would show a horizontal hum bar across the screen (light shaded bar that may or may not move up across the screen. And, of course, it was of an intermittent nature. On some sets a slight bump on the chassis would clear up the hum for a short time.

The first trouble was located on the ZA power supply (see Fig. 65) and DC regulator panel. It was found that the large C3 capacitor (a 1000 mfd unit) would break loose on the circuit board and required resoldering. Also some of these ZA panels were not making a good chassis ground connection. To insure a good connection, scrape the insulation coating from around the ground mounting clips and make sure the panel fits tight to insure a good ground connection. Also check and make sure capacitor C2 has a good electrical solder connection to the panel.

Another fault in the main chassis frame will also cause this same hum bar problem. And this is C205, a 10 mfd capacitor that is part of the power supply filtering system. This capacitor has been known to open up. Should you have a hum bar problem in this chassis the above "tips" will clear the picture up considerably.

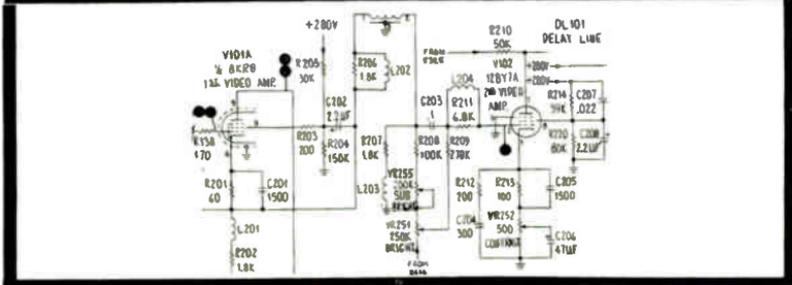
FIGURE 66

Color picture lacks detail or the picture appears out of focus, but the focus voltage is correct. Check and replace delay line DL101 if it is shorted or has leakage to ground. If the line is shorted, the signal will not be delayed and will lead the color signal on the CRT.

If the color picture lacks detail (appears out of focus) and is getting no monochrome signal, check and replace the delay line if found to be open. Without Y, the color signal has no detail. Note video circuit in Fig. 66.

3. Internal capacitors to ground may be open. A common trouble is an open coil and some of the older color chassis delay lines were open on the ground side. This would cause standing waves and produce ghosts on the picture. These ghosts could not be eliminated by antenna adjustment or by the fine tuning control. It should be noted that misalignment in the IF stages will cause ringing and this does change with fine tuning adjustments. If the delay line is suspected, clip a jumper test lead across the two video signal leads. If the ghosts get lost and the picture clears up, this proves the delay line is defective. Also, a short from the delay line to ground, or an open delay line, will, in most sets, cause a loss of both raster and picture information.

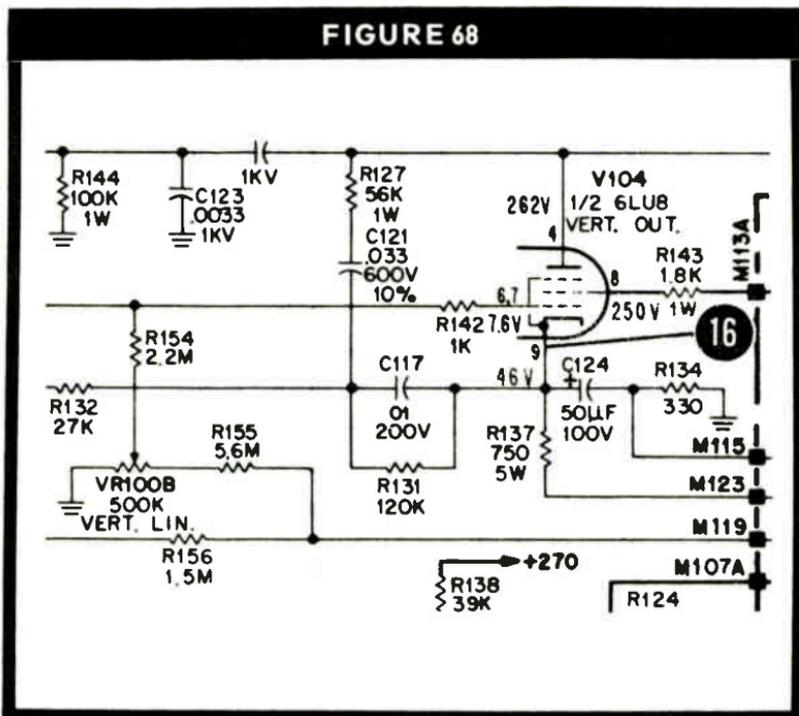
FIGURE 68

On some of these chassis we have seen cases where capacitor C117 in the vertical oscillator cathode was a .01 mfd 200-volt. This should be a .01-mfd rated at a 600 volts. In the event of vertical jitter on the bottom of the raster or foldover, C117 should be checked to determine if the voltage rating is correct. If not, make sure a 600-volt rated capacitor is used. See schematic in Fig. 68. If you have one of these chassis in the shop for other repairs, C117 should be checked for proper voltage rating, and if incorrect, it should be replaced to prevent failure in the future.
