199 Color TV Troubles & Solutions

by R. L. Goodman

FIRST EDITION

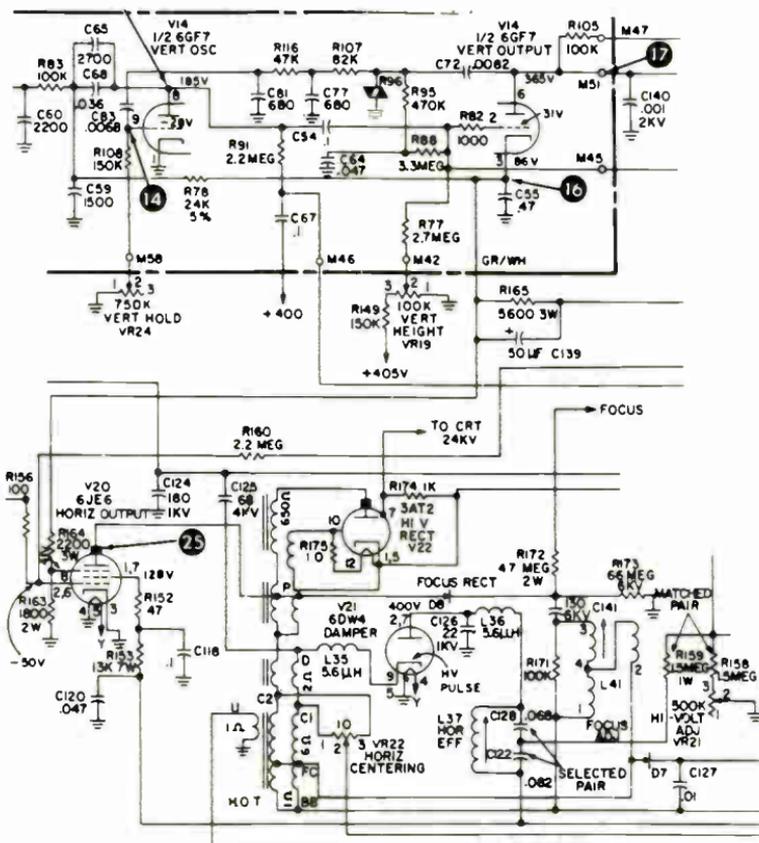
FIGURE 72

Should the trouble be insufficient height with complete foldover, the trouble is usually an open 80-mfd filter in the plate supply of the vertical output tube. If there is a loss of sweep, the trouble may be an open 1000-ohm resistor in the vertical output tube (V14) grid circuit. If the height is insufficient, the fault is usually either a defective booster-boost diode D7 or an open or increased value R164 (2200 ohm, 3w), which completes the vertical output cathode circuit to ground. These circuits are shown in Fig. 72.

This is usually an intermittent condition, with wide color bars (generally red) drifting through the picture vertically. Other symptoms are poor sync, loss of color, picture may go black, tube filaments go out and the picture is of poor quality.

All of these symptoms may be caused by poor grounding between chassis projections and grounding eyelets on the PW panel. The symptoms in each case obviously depend upon the panel involved. To correct, solder a wire between the grounding point on the panel bottom and bring it out to a good chassis ground point. Resoldering of the eyelet ground may not always be a very satisfactory solution.

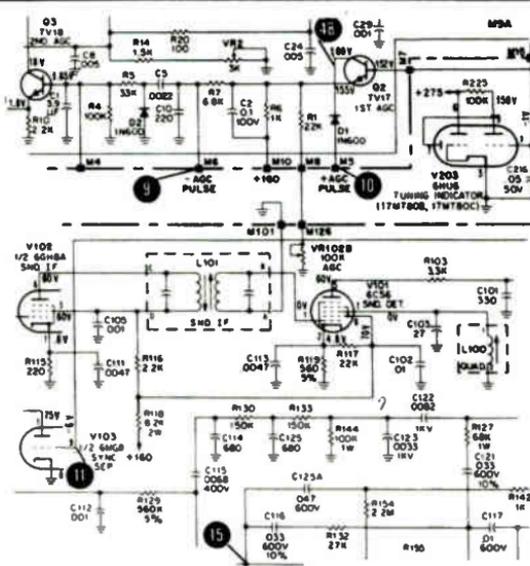
FIGURE 73

The other symptom was poor vertical interlace. The picture also had black-and-white vertical bars (horizontal interference) and no video on strong stations. The probable cause is a defective capacitor C1 (3.9 pf) found in the base circuit of transistor (Q3) the AGC amplifier stage. Refer to Fig. 73.

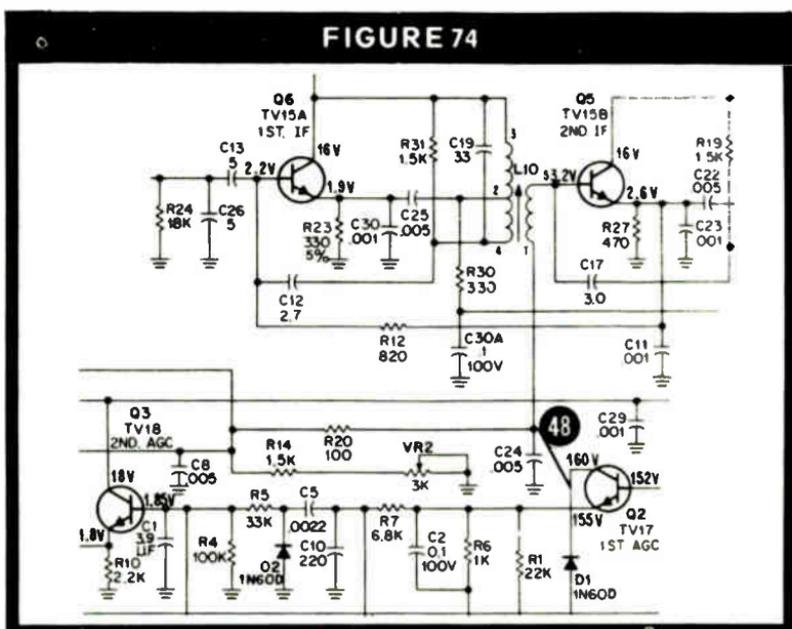
This chassis had hash and dark streaks, mostly horizontally, across the screen, which may be due to the misadjustment of AGC control (VR2) on the IF panel, Fig. 74. The IF AGC with no signal (AGC gate inoperative) will be about 3.2 volts after proper VR2 adjustment. Note: Place the channel selector knob between channels to obtain a no signal condition.

This color receiver produced a very weak negative picture with oscillation hash. The trouble is caused by a reverse bias on the third IF stage. Certain external AGC voltages applied to this stage may give a positive picture of considerably less than the 1.5 volts normal peak-to-peak signal that should be found at the video detector. The probable cause for this picture symptom is an open 3-pf, neutralizing capacitor in the second IF stage. The Q5 transistor stage shown in the schematic of Fig. 74.

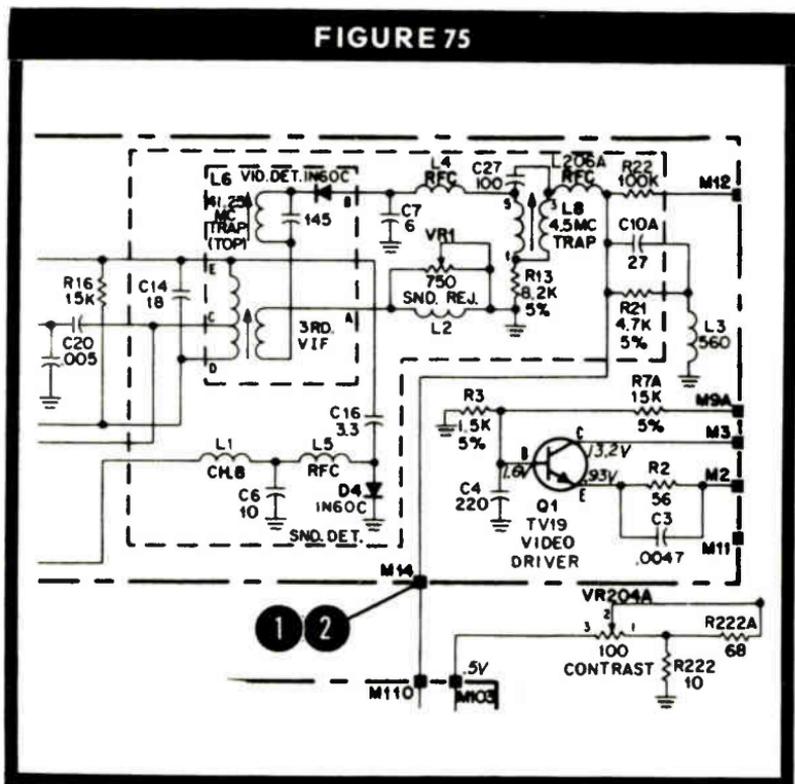
FIGURE 75

For this problem make the following checks: Refer to the schematic in Fig. 75. The 41.25-MHz trap (L6 top) may be misadjusted.

The AGC voltage may also be incorrect. Check for a defective third IF transformer or faulty video detector diode.

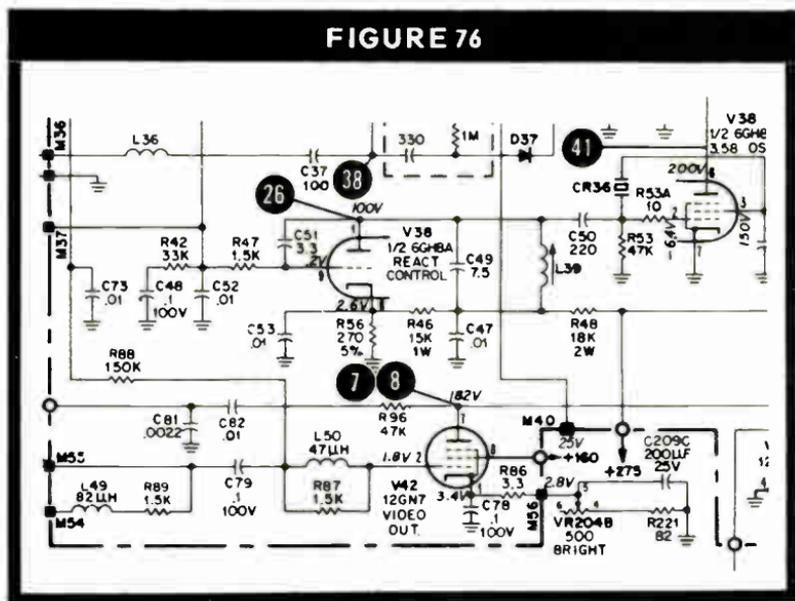
FIGURE 76

To cure this problem replace capacitor C209C, 200 mfd. 25v. across the brightness control in the cathode of the video output tube (12GN7) shown in Fig. 76.

To correct this, properly dress the orange B+ lead coming from terminal strip B6 (lug 5), going past the IF panel along the front chassis apron, and terminating on strip B4 (lug 5). This lead should be dressed away from the IF panel toward the front apron and down close to the bottom of the chassis. Also check filter capacitor C208A.

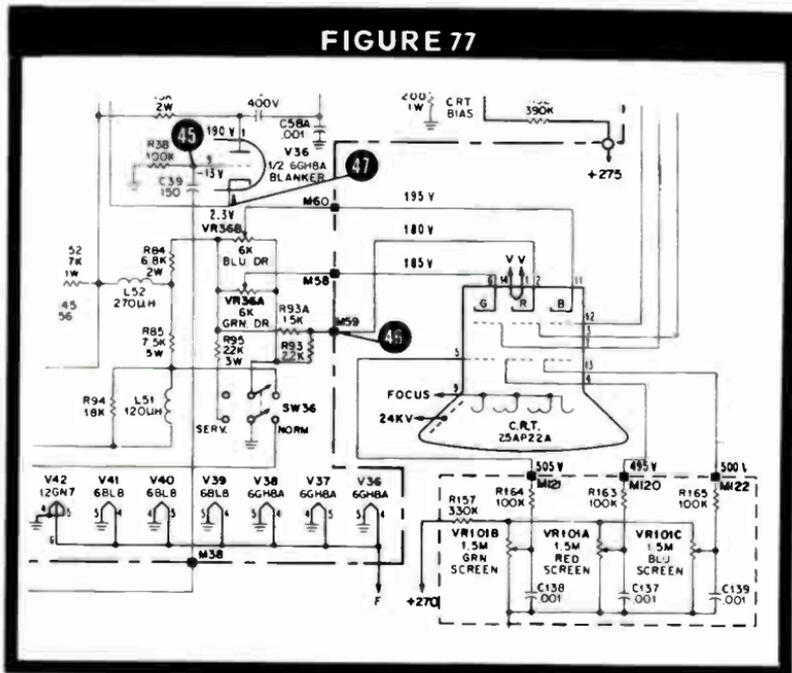
FIGURE 77

Check the horizontal output transformer and associated circuitry. A defective focus coil or damper tube may cause the sweep transformer to fail. Check the anode cap dust cover. Carbonization of the anode cap can lead to CRT and sweep system failures. Check and clean the HV button area.

With no raster (raster is present when the service switch is in the service position), check the plate voltage of the video output tube and L51 (video peaking coil). Note schematic in Fig. 77. The open plate circuit will cause the CRT cathode voltage to increase to the point of CRT cutoff. Also check the video output (12GN7), it can cause the same symptom.

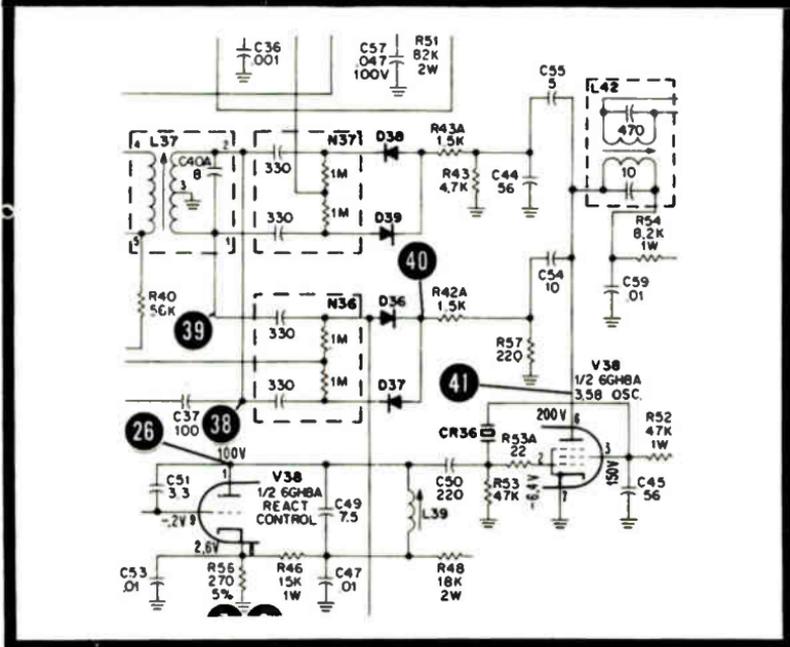
FIGURE 78

If there is a good black-and-white picture, but no color, replace the 3.58 MHz oscillator tube (V38), check the crystal (CR36), plate voltage, transformer L42, and associated oscillator circuits. See the schematic for this color circuit in Fig. 78. Note: When checking for color, always make sure you have good B&W reception first.

If there is random color reception, this indicates the 3.58 MHz oscillator is operating but not on frequency. After tubes have been checked or replaced and the trouble still persists, check resistance coil L39. To adjust L39, short TP39 to ground and adjust the reactance coil for color sync zero beat. Replace the crystal if drift is beyond the control range. With your scope, check the blanker pulse, which can affect the bandpass amplifier and the phase detector stages.

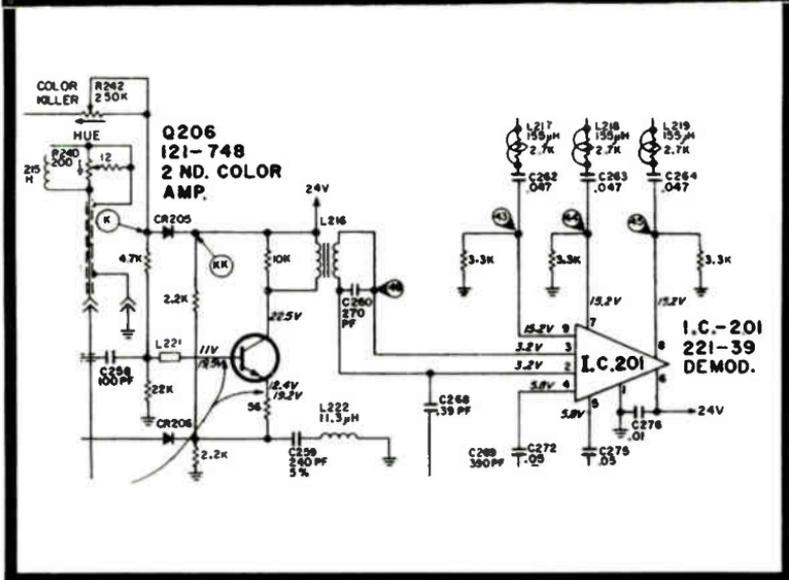
FIGURE 118

The color picture did not look right. Colors were weak or the wrong tint. Also, the hue control had very little affect. The "tip-off" is this: With the color level control turned down, no color, just a black-and-white picture, the CRT screen gray scale will change as the hue control is rotated, usually from a green to a blue tint. The probable cause in a defective IC color demodulator chip, part number 221-39. It has caused this type problem in several chassis. Refer to Fig. 118 for circuit schematic.

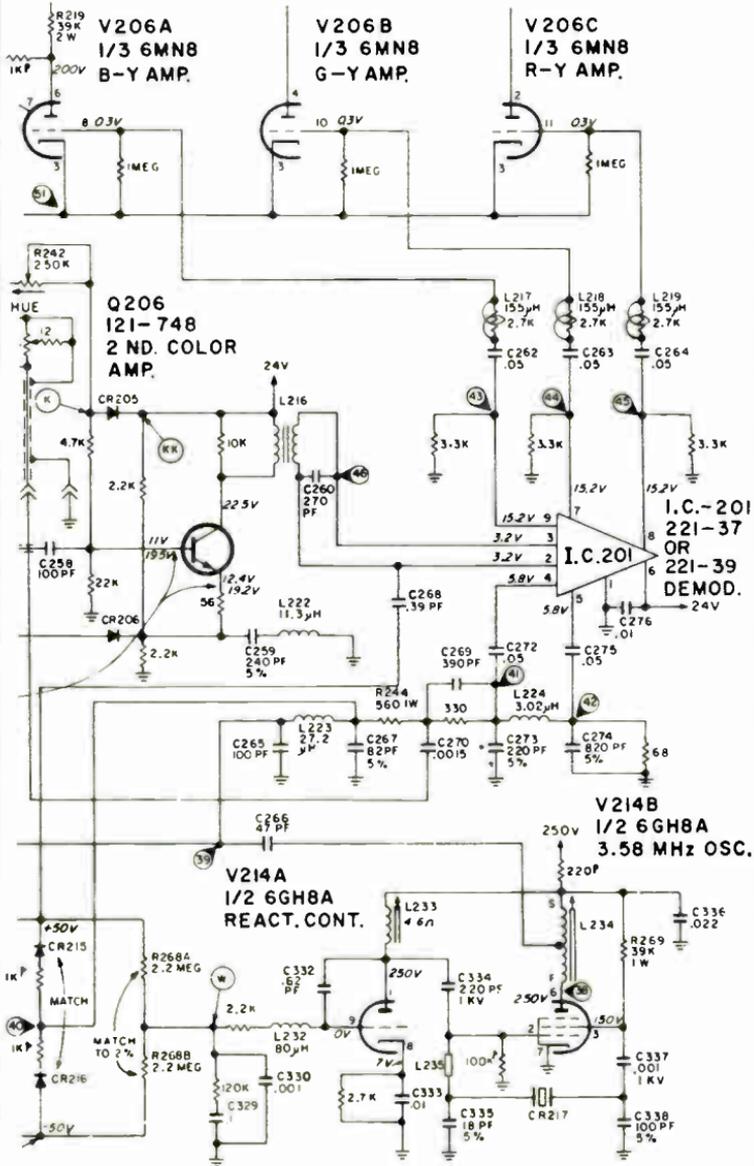
FIGURE 119

A. The screen color shading varied across the CRT from blue on the left side of the raster to black-and-white center and green on the right side. Look for a defective C266 (47 pf) coupling the 3.58-MHz CW from the color oscillator plate to the phase delay line. See the schematic in Fig. 119.

B. Picture blurred and milky looking, caused by an intermittent focus condition. Check for a loose black lead (focus connection) at the CRT socket. Replace the socket if defective.

C. This set had a blue picture when it was switched off channel and then back on again, but only when a station was broadcasting color information. The condition was due to a floating (open) grid connection on the (B-Y) color difference amplifier, the 6MN8 tube socket.

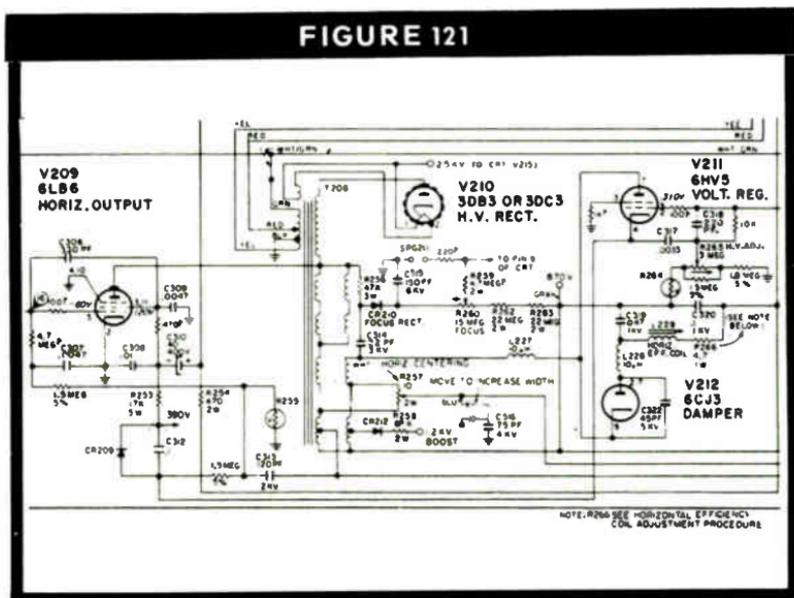
Two different component failures in this chassis were found to cause the same picture symptom. The picture had a "pie crust" or "cog wheel" effect that was accompanied by a shimmering picture.

In one chassis this problem was caused by a defective resistor (1000-ohm that had increased in value) at pin 3 of the 6HV5 pulse regulator tube socket. (See the schematic in Fig. 121.) Probable cause for the resistor fault was a shorted 6HV5 tube. Replace the 1000-ohm resistor and the 6HV5 tube. Check the high voltage and adjust if needed.

For the second chassis, which also had the same picture symptom, the problem was traced to a faulty VDR (R255) located in the horizontal sweep output circuit. This is a rare problem.

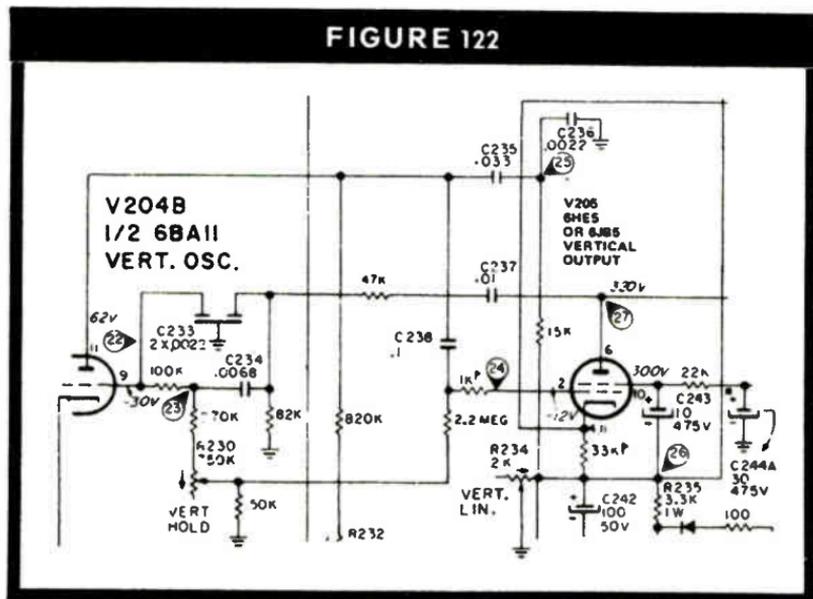
FIGURE 122

Picture pulls in from the top and bottom and wants to roll vertically. This problem may also be of an intermittent nature. This symptom may also appear in other Zenith color chassis that use this same vertical sweep circuit shown in Fig. 122.

After this set was on a few minutes the vertical oscillator would stop and only a bright vertical line appeared across the screen. The oscilloscope and VTVM were not much help. In fact, when the probes were touched to any part of the vertical oscillator circuit the trouble would clear for a few minutes. A faulty capacitor in the feedback network was suspected, but this was not the case. The defective part was found by substituting resistors in the feedback circuit. The 47K resistor, located between capacitors C237 and C233, had increased in value to 850K and the feedback pulse was too small to sustain oscillation. A very rare and hard to locate malfunction.

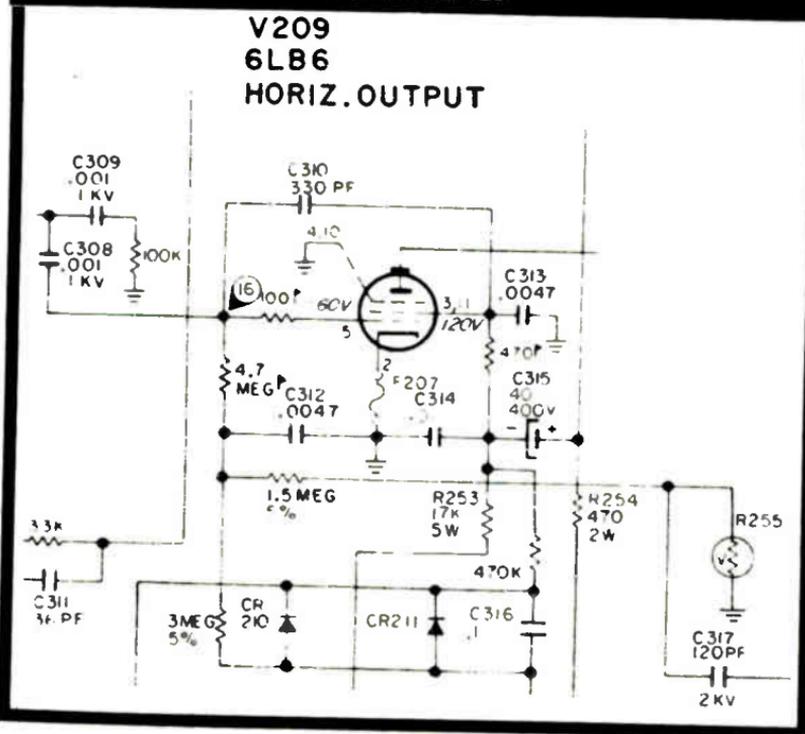
FIGURE 125

It has been found that at high line voltages (130v), the ½-watt 470K resistor in the screen grid circuit of the 6LB6 may overheat and possibly open. See Fig. 125. This will cause a loss of HV and raster and open the fuse in the cathode of the 6LB6.

Service Tip: Check the connection of the 470K resistor to the 390v B+ line. The above condition may exist if the 470K resistor is connected to the boost voltage terminal instead of 390 volts. Change the connection if not as indicated. If the condition exists, also check R263 (17K) and the 470-ohm resistor in the screen circuit.

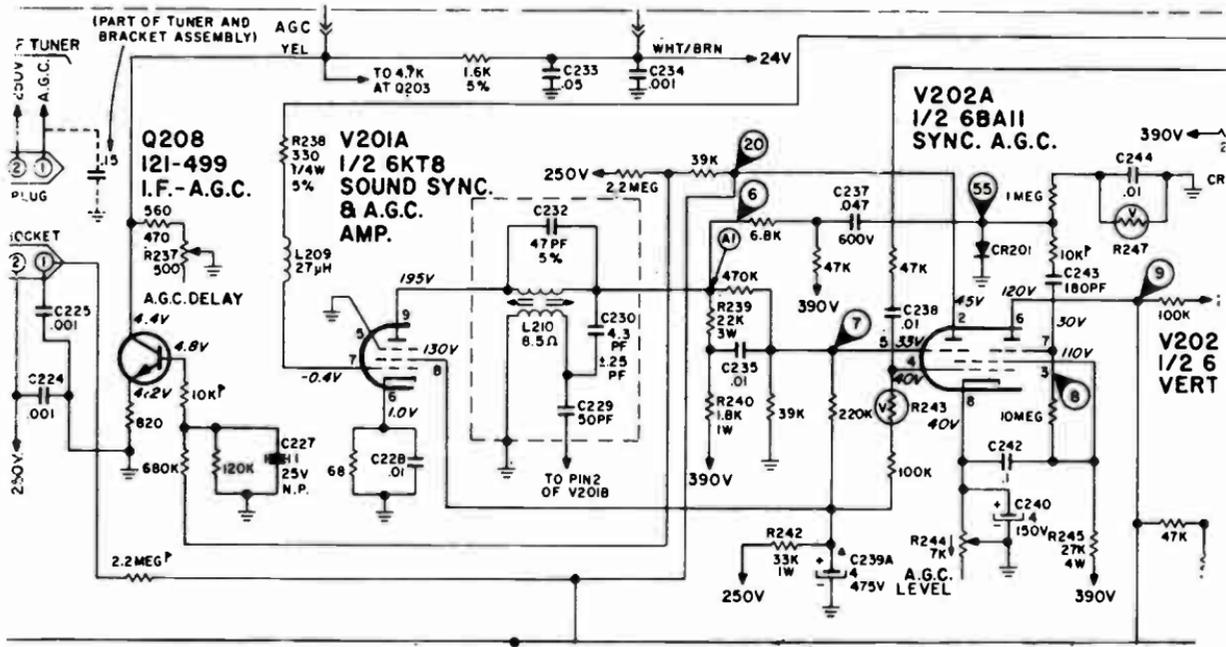
FIGURE 126

The picture on this color set displayed a loss of picture sync locking action with only "flashes" of color showing up in the picture intermittently. This behavior was puzzling to say the least, so we delved right into the sync and AGC circuits as shown in the schematic of Fig. 126.

All of these troubles were caused by a defective (open) capacitor C243 (180 pf) in the sync and AGC stage. Also check diode CR201, as it will cause this same picture trouble symptom should it become defective. Replace C243 or diode CR201 and readjust the AGC and AGC delay controls as required.

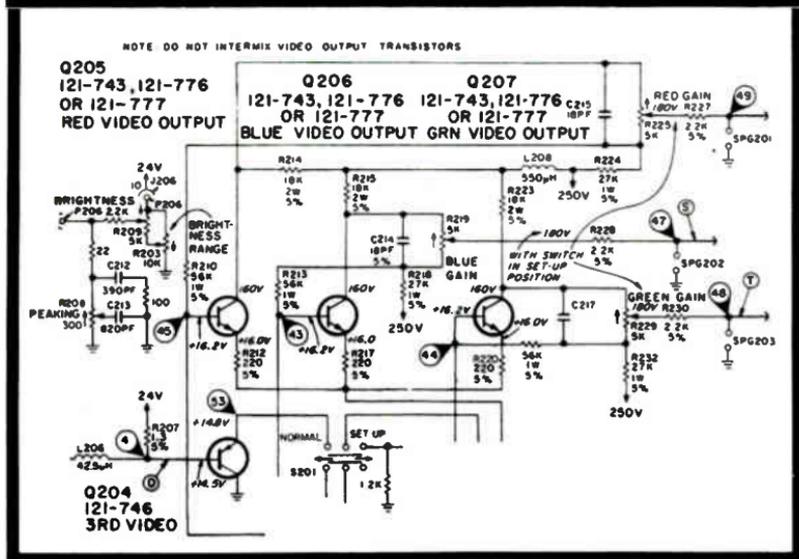
FIGURE 127

Probable Cause: Open third video amplifier transistor (121-746). Refer to Fig. 127 for this video amplifier circuit. This transistor fault will simulate a "blanking" condition.

Possible Cause: A shorted third video amplifier transistor (121-746) which will reduce the CRT cathode-grid bias.

Note: In the two above case-histories the "set-up" line could be "normally" adjusted with the G2 controls, indicating a "Y" channel malfunction. See Fig. 127.

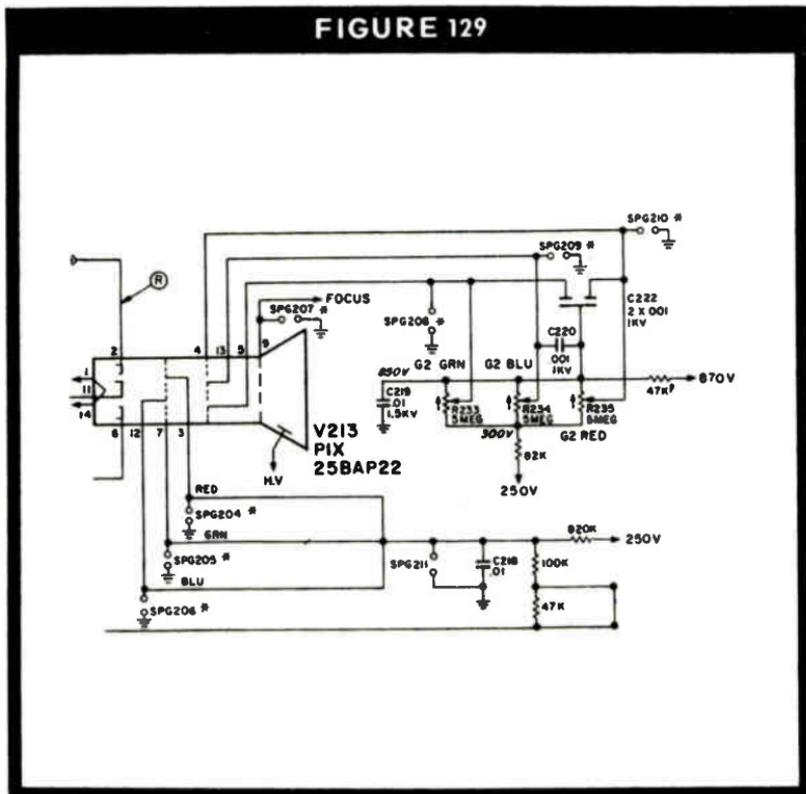
FIGURE 129

At times the picture on this set would be too bright. Along with this intermittent brightness condition, it was noted that the set-up line could not be obtained. These were the tip-off symptoms.

The cause of this trouble was a shorted capacitor. This is C218 (see Fig. 129), a .01 mfd capacitor in the control grid circuit of V213, the color CRT. Also, check or replace spark gap SPG 211.

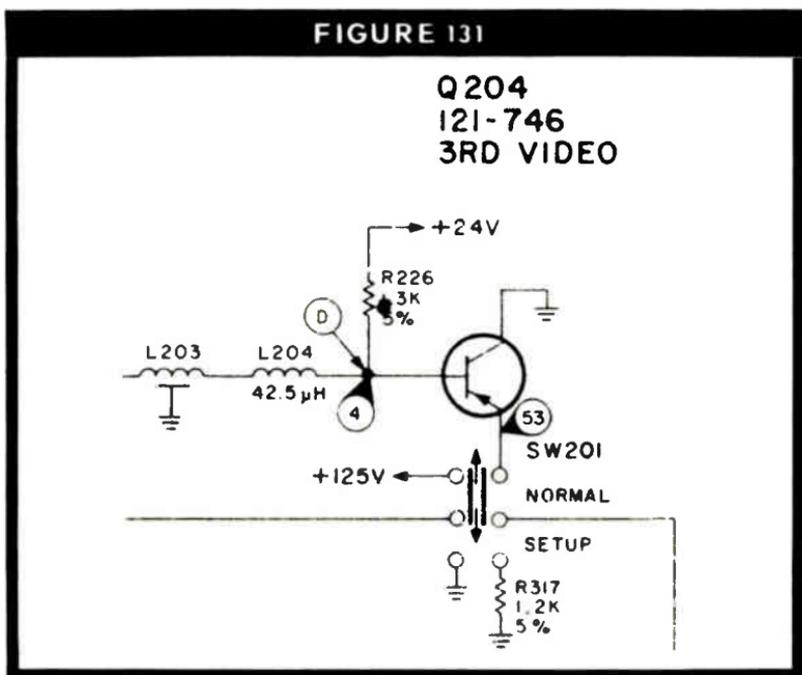
FIGURE 131

The trouble appeared to be due to an antenna fault. Actually, the trouble was a faulty transistor, 121-746, third video amplifier shown in Fig. 131. By accidentally "healing" the transistor, the brightness increased excessively and AGC action was also affected. Retracking and readjusting the AGC resulted in a normal picture without "ghosts." After a little circuit coolant was applied to the transistor, it would break down again. Readjusting the AGC again caused the ghosts to reappear. A new transistor and alignment solved this spook problem.

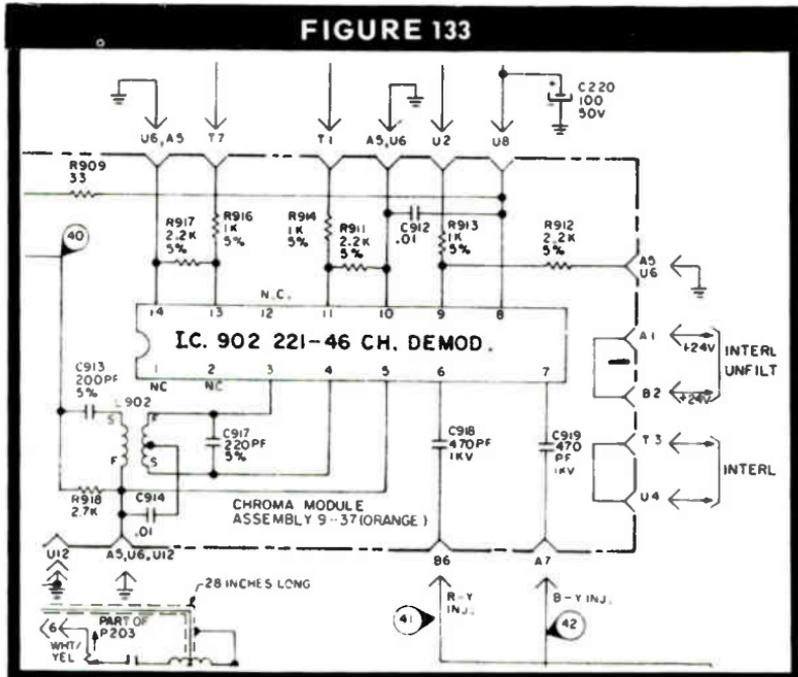
It was noted when the picture went dim that the screen controls and brightness limiter control would brighten the screen up. but the picture had a negative appearance. However, the "tip-off" came when we noticed that the color was missing.

For a fast check, the chroma module assembly was changed (Part Number 9-34 orange color) and the picture and color reception returned to normal. Refer to Fig. 133 for this module circuit. The IC "chips" on this module were changed and IC 221-46 (chroma demodulator) was found to be defective. After the "chip" is replaced, make an APC color alignment and cross-talk adjustment.

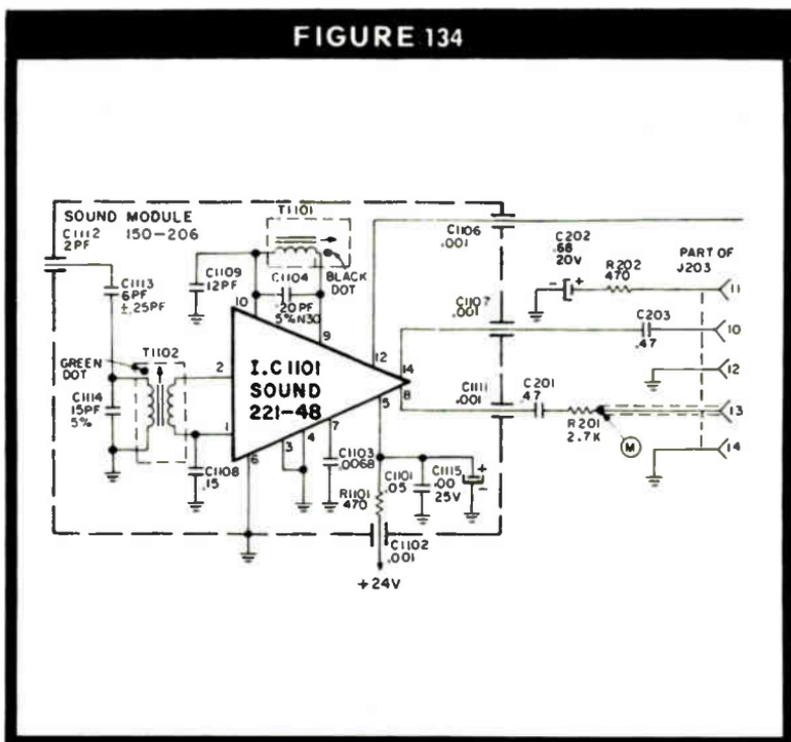
FIGURE 134

Sound went off after set warmed up, or it was intermittent. Check the sound module. Part Number 150-206. Both conditions are caused by a defective transformer T102 or poor solder connections on the circuit board shown in Fig. 134. Also the sound "chip" (IC1101) may be defective. Repair the circuit board or replace the faulty components. As a last resort, replace the sound module assembly. However, don't overlook Q103, the sound detector amplifier found in the IF sub-assembly. Also, check the plug and cabling connections.

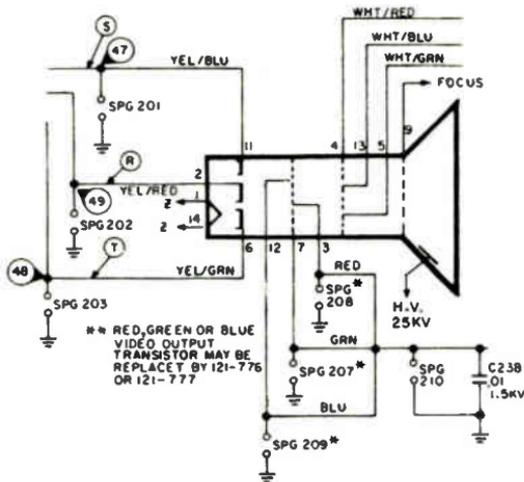
FIGURE 135

There wasn't a trace of blue in the color picture. Voltages at cathodes of the CRT were found to be correct. (See the schematic in Fig. 135.) The CRT grid voltages were normal, as were the C2 voltages. Voltages at the three video output transistors were normal, too. A very dim blue line could be achieved with switch in the setup position and the blue G2 control at maximum. Voltage at the center arm of the blue gain control read 20 volts lower than the other two.

This trouble was caused by a defective (open) resistor, R292 (2.2K) in the blue video output stage. Replace the resistor and perform gray-scale tracking adjustments if needed.

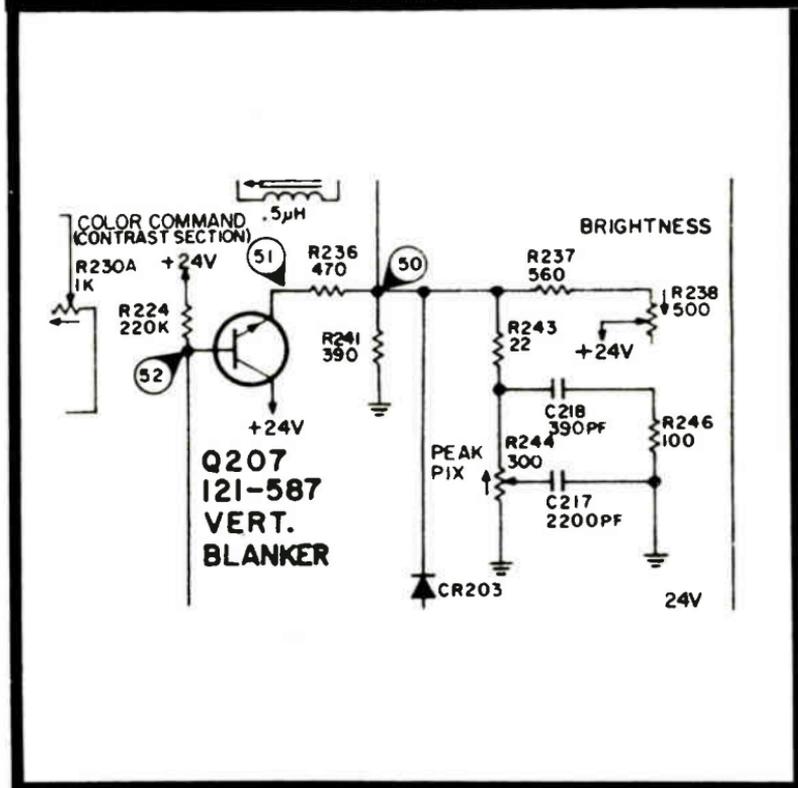
FIGURE 136

In this chassis the fault was a defective picture peak control (R244) shown in Fig. 136. The control had developed leakage to the case. The resistance from high side to ground read approximately 150 ohms at certain settings of the control.

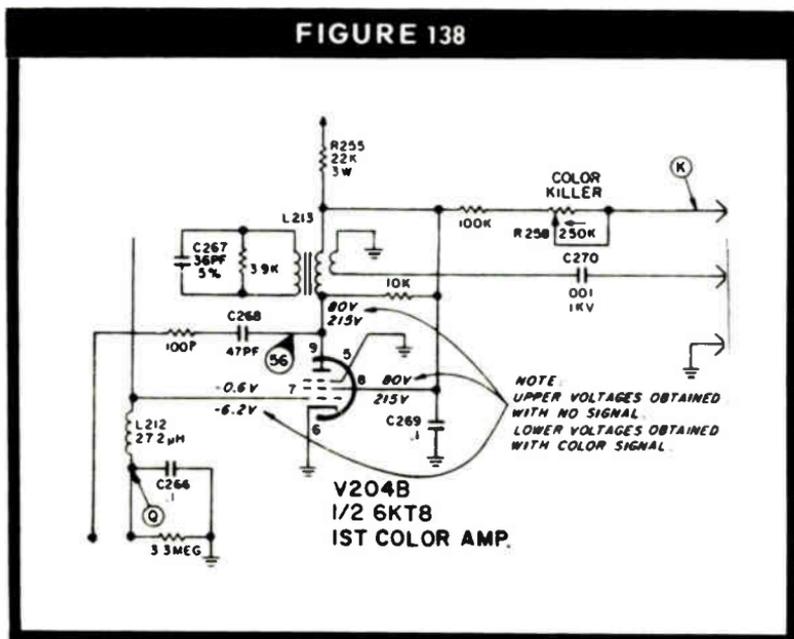
This set appeared to have no color, but a close look revealed a very weak, washed out picture. All voltages in the color section checked very close to normal. The trouble was found by signal tracing the chroma waveforms with an oscilloscope.

The trouble was found, and this can be a tough one, to be an open winding in the first color amplifier transformer (L213 plate winding). The plate voltage, pin 9, of this stage checked about normal, because of the 10K resistor from the screen grid, pin 8, of this circuit. However, the scope caught the loss of color gain for this stage in short order. Replace the transformer and align the color amplifier stage. The circuit is shown in Fig. 138.

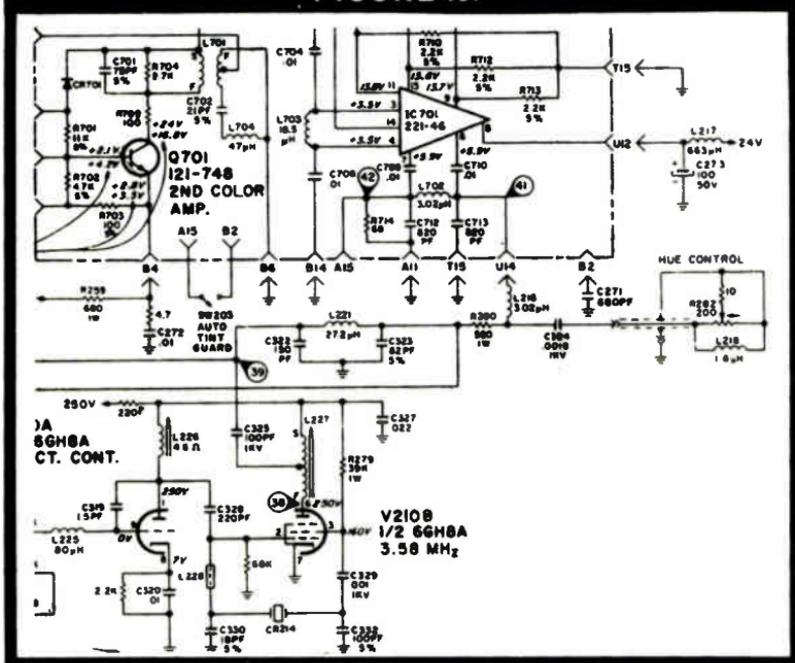
FIGURE 139

After checking the 3.58 MHz oscillator circuit (shown in Fig. 139) with an oscilloscope, the trouble was narrowed down to resistor R280 (560 ohms) which had increased in value to 1.5K and weakened CW drive signal to the chroma demodulator "chip." This resistor is located in the coupling circuit between the 3.58 MHz oscillator output and input to the demodulator.

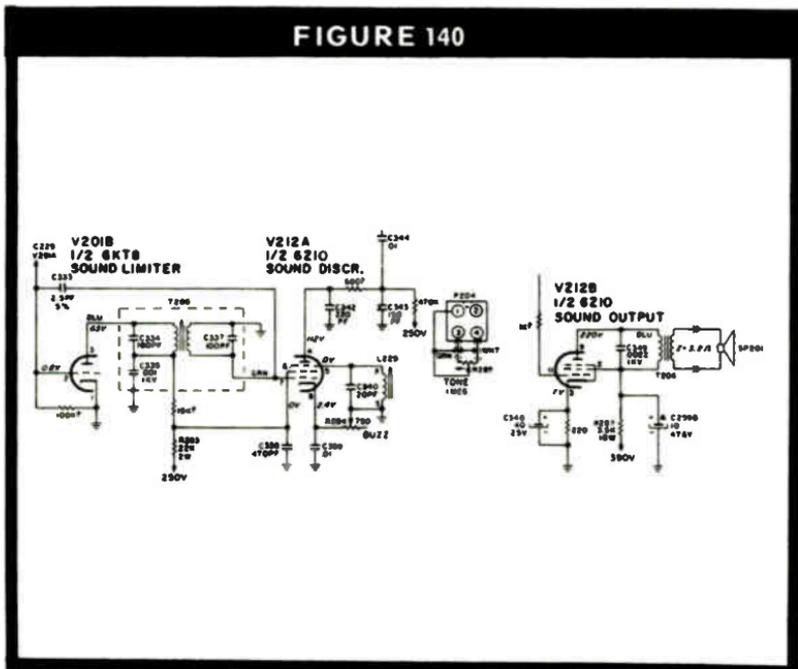
FIGURE 140

This color chassis was producing an excellent picture, but the sound level was low and a slight distortion was noted. New tubes in the audio stages did not help. All voltages in the sound section were measured, but were found to be normal. (See Fig. 140.) An audio signal tracer was used and all of the stages appeared to be working properly. On a "hunch," the audio output transformer (T206) was replaced by a new one and the sound came on loud and clear.

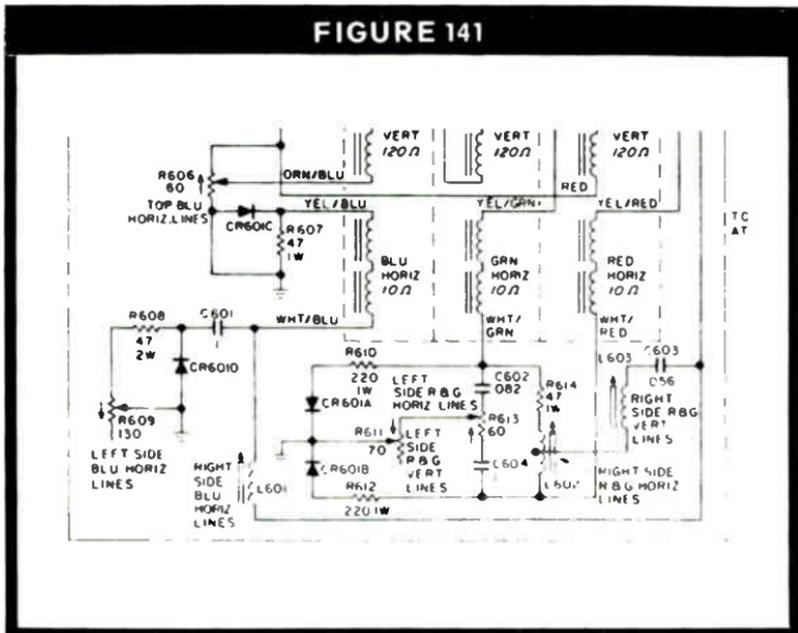
FIGURE 141

The picture on this set was good except that blue bled out from the picture details on the left side of the screen. A cross-hatch generator showed very poor blue convergence on the left side of the screen. Some touch-up convergence adjustments did not help. However, the left blue horizontal lines control had no affect on the pattern, so this was a good clue. We took a good look at the convergence assembly panel. It was found that this control, R609 (see schematic in Fig. 141), had opened. A few more checks were made to find out why R609 went up in smoke. The trouble actually started when diode CR601D shorted out. There are four diodes in this unit, so replace the complete package and make a convergence check.

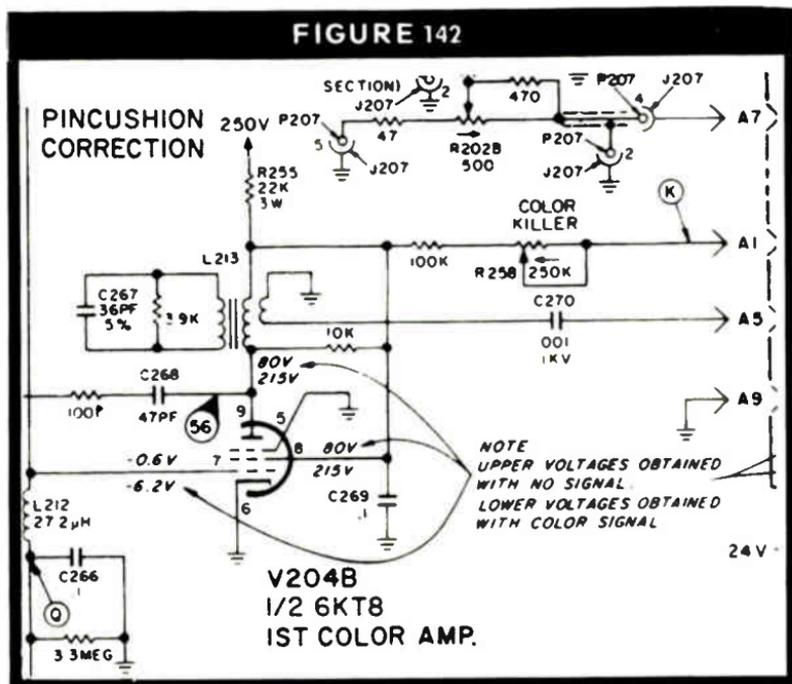
This Zenith color set had a very weak, washed out color picture. It was so weak that the complaint was no color at all. Later, on the service bench, it was noted that all voltages in the color section checked out very close to normal readings. This could have been a tough one to find, but the oscilloscope made it easy. The problem was located in the first color amplifier transformer, L213, shown in Fig. 142. The secondary plate coil winding was open. The plate voltage, pin 9, of the first color stage was about normal because of the 10K resistor feeding voltage from the screen grid, pin 8, of this stage. However, the oscilloscope caught the loss of color gain in this stage very rapidly. After the transformer was replaced and color alignment performed, bright color once again appeared on the screen.

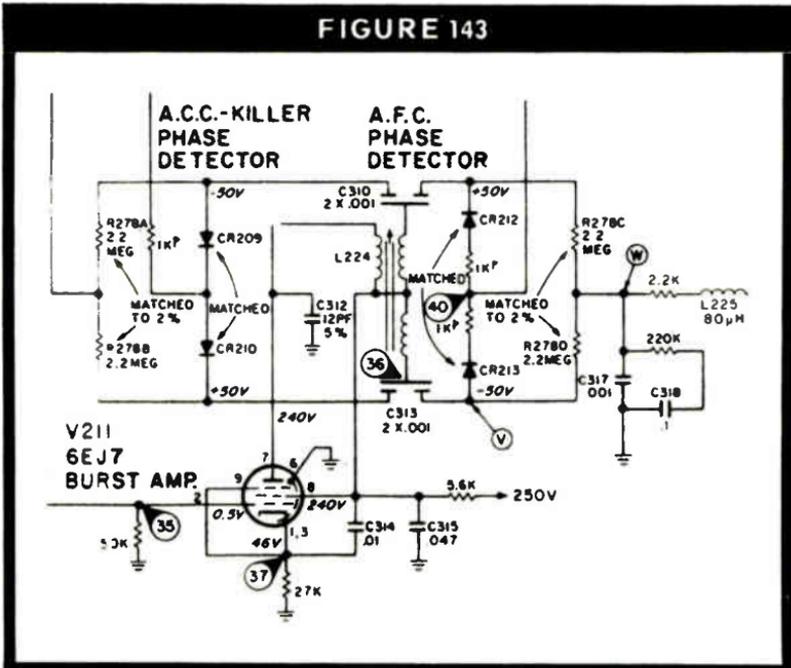
FIGURE 143

The problem was found to be defective AFC color phase detector diodes, a matched pair of diodes shown as CR212 and CR213 in the schematic of Fig. 143. Replace these diodes and zero beat the 3.58-MHz oscillator.

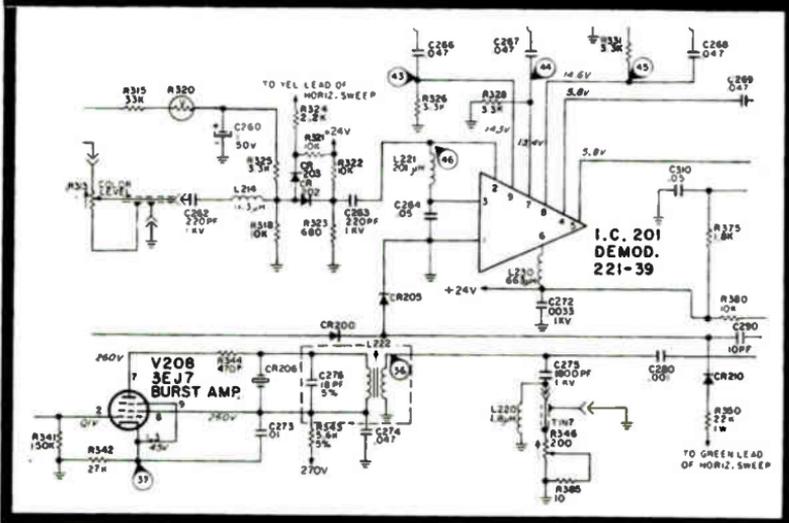
FIGURE 145

This small portable set had a sharp black and white picture but not a trace of color. For a problem of this nature you should defeat the color killer stage if the set has one and then measure the automatic color control voltage (ACC). In this chassis the ACC voltage at test point A measured .50 volt and this was cutting off the 1st color amplifier stage. Diode CR210 (Fig. 145) was found to be faulty (open) and was causing incorrect ACC voltage at the color amplifier grid. If diode CR200 opens, it will also cause a no color condition. And if diodes CR201-CR202 were faulty, you would not have any blanking to the "chip." These diodes also eliminate any ripple voltage between blanking pulses that are used to provide a low amplitude pulse for cutting off the color demodulator chip (IC201) during the horizontal blanking interval. Leakage in diode CR210 may cause strong color with no ACC action at all.

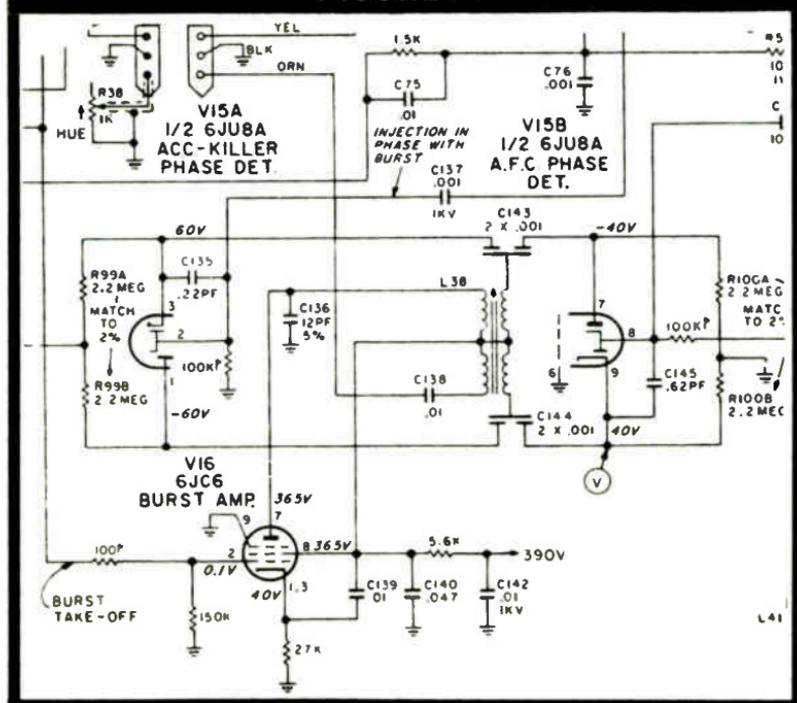
FIGURE 147

The trouble was located and a look at the color circuit in Fig. 147 will show how this can happen. Capacitor C138 located between the phase detector coil (L38) and the hue control becomes shorted and puts B+ to ground through the 5.6K screen grid resistor of the burst amplifier stage V16, thus blowing the fuse. And this will also burn up the hue control and the 5.6K resistor. Replace C138, a .01 mfd capacitor, the 5.6K resistor and the hue control. Then check for proper hue control tint range and adjust if needed.

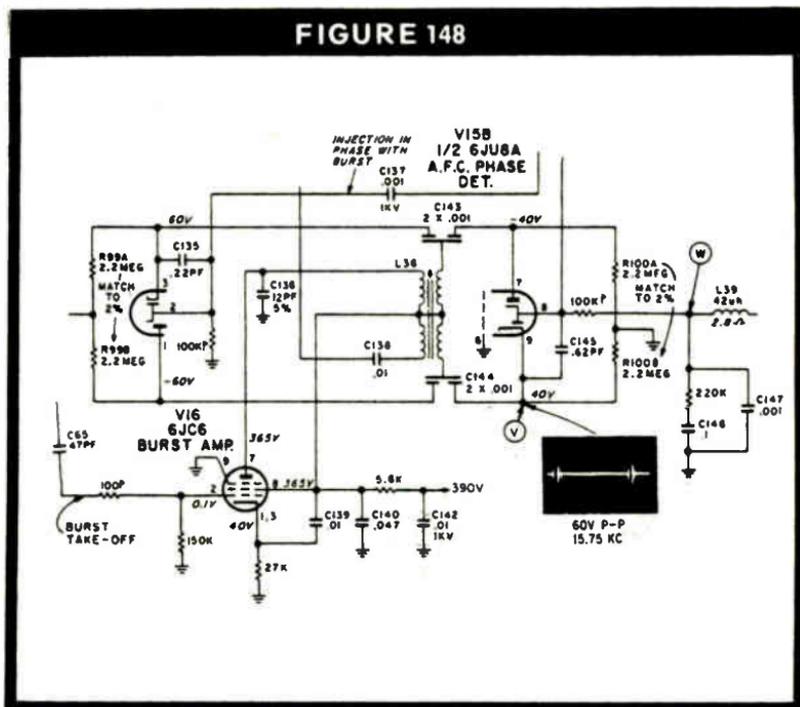
This set displayed a color picture sync problem. The voltage checked at test point "W" would only swing plus and minus one volt. An oscilloscope check revealed a faulty gating pulse at the burst amplifier plate circuit. The color burst and video were present at the grid.

The trouble proved to be a faulty 47 pf capacitor coupling the chroma signal to the burst amplifier grid. (See the schematic in Fig. 148.) As a result the color burst amplifier stage conducted continuously. A new capacitor gave us good color picture lock.

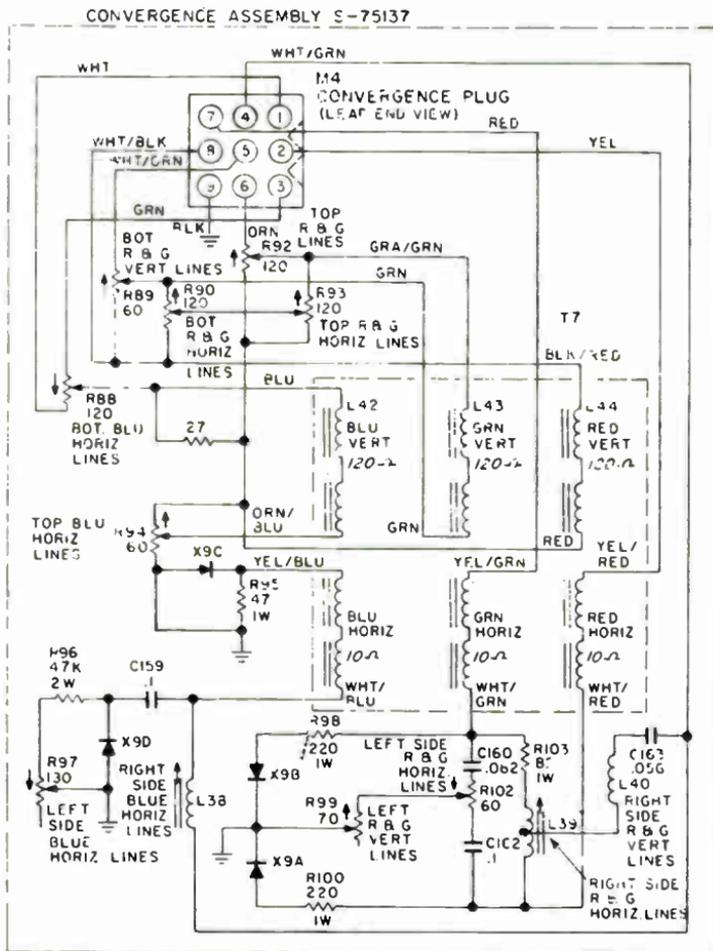
FIGURE 149

If the red and green horizontal lines on the left side of screen will not converge, check with an oscilloscope for proper waveforms coming into the convergence panel, see Fig. 149. If the waveform is correct, but you have a bow in the horizontal lines, check the clamping diodes.

This chassis had a defective X9B clamping diode. These diodes will short, open or develop leakage.

The diodes are used to "clamp" the dynamic convergence sweep at the screen center, thus giving the beams more effect at the ends of each sweep. A defective diode will cause the line to bow and the controls will have no response.

Short out the diode and the line should bow; if it won't, the diode is shorted. To check for an open diode, just bridge a good one across it and look for results. Of course, other troubles on the panel could be defective coils and controls. This same problem has occurred in many other makes of color TV sets.

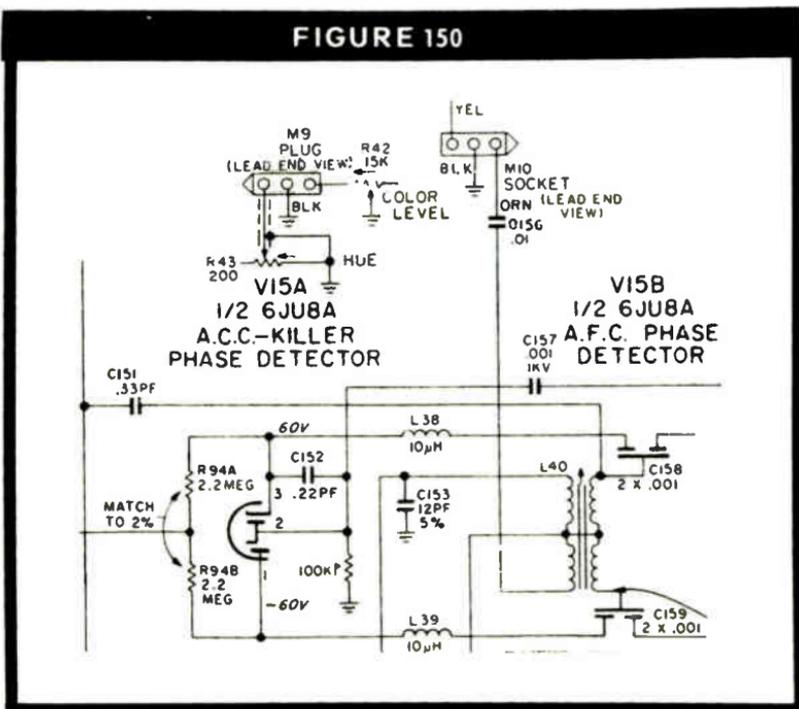
FIGURE 150

The hue control varied the color level and had very little affect on the phase variance. This can be a tough one to troubleshoot because the defective component may check out good. Also, the voltage at the control grid of the 1st color amplifier stage has a 3-volt range variance as the hue control is rotated through its full range.

Capacitor C156, a .01 mfd unit (Fig. 150) in series with the arm of hue control R43, had developed leakage. Replace C156 and touch-up the AFC phase detector transformer, L41, if needed.
