199 Color TV Troubles & Solutions

by R. L. Goodman

FIRST EDITION

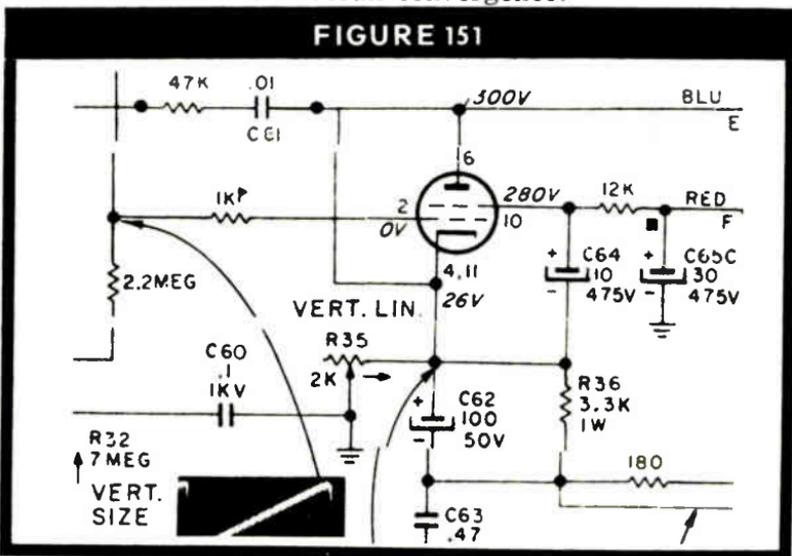
An in and out of convergence drift problem found in this chassis was a "rare" trouble. When the channel selector was turned off station, then back on, or even during a sudden picture change, it looked like the convergence dropped out. But then, after about 5 or 10 seconds, the picture would slowly drift back into proper convergence. This symptom was very pronounced with a cross-hatch pattern on the screen.

This "video information transient" symptom is very likely caused by a faulty electrolytic capacitor. The most likely faulty ones (intermittently open with a high power factor) are the large value electrolytic capacitors in the vertical sweep or convergence pulse forming circuits. The component which caused this odd drift problem in this set was the large 100 mfd electrolytic unit in the cathode circuit of V10, vertical output stage, which is shown as C62 in the schematic of Fig. 151. This capacitor is not only a cathode bypass, but it also shapes the vertical dynamic convergence pulses that are fed into the convergence control panel. Replace C62 and then recheck the overall convergence.

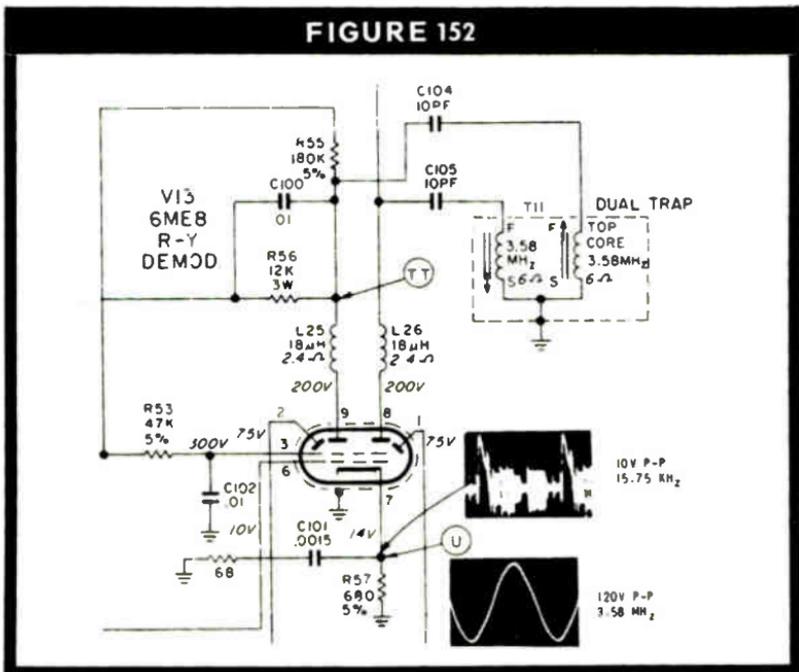
The picture on this color receiver displayed weak "reds" during color program reception. In fact, the overall color information appeared to be weak. This weak color threw us a curve as we went right to checking the chroma amplifier stages. However, the trouble was found in the R-Y demodulator stages shown in the schematic of Fig. 152. A faulty resistor (680 ohms) in the cathode circuit of V13 (R-Y demodulator) had increased in value to 3000 ohms.

Service Note: Weak color(s) may also be caused by an open peaking coil(s) L19, L20 or L22 in the output circuit of the demodulators.

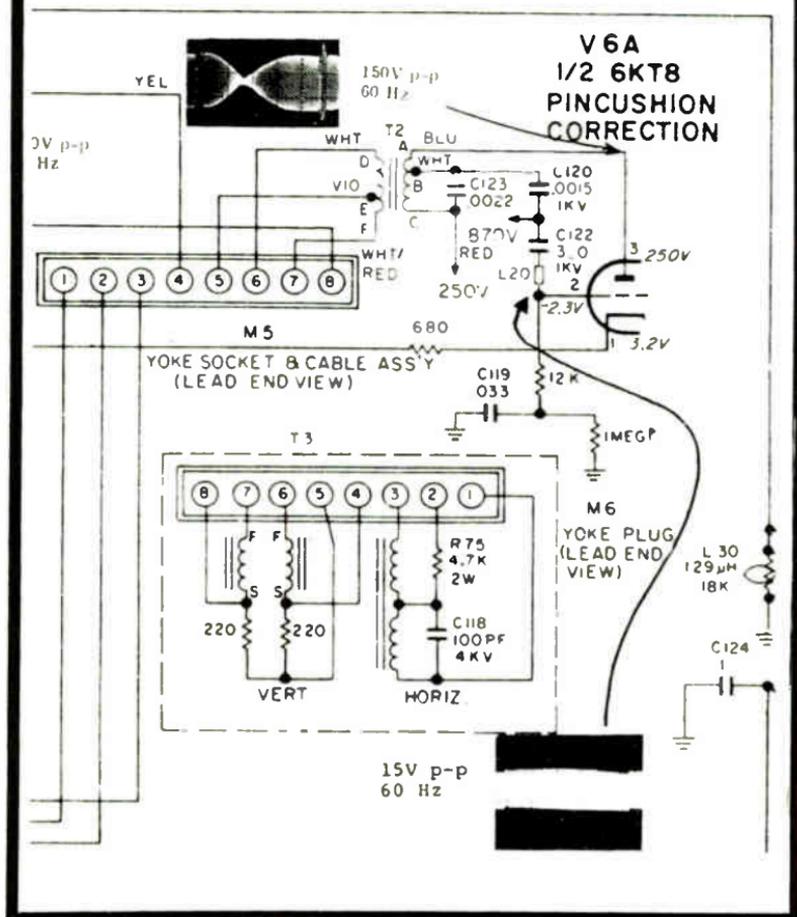
FIGURE 159

This rare malfunction in the deflection circuit of a color TV receiver can cause ringing. Raster lines which appear as sine waves (approximately $\frac{1}{8}$ " in height) for the first few inches of horizontal scan may not be due to a fault in the horizontal sweep circuits as one might suspect.

For example, should the center tap of the pincushion transformer open (i.e., broken connection at the deflection yoke plug, (see Fig. 159) the AC ground for the circuit would be removed. Also, the two damping resistors across the vertical deflection windings would be removed. As a result, the vertical and horizontal windings would be more subject to crosstalk. The natural resonant frequency of the vertical windings is approximately 240 kHz. During horizontal retrace time (collapsing of the sweep voltage), considerable energy is released in the horizontal windings and it is coupled into the vertical windings. This can set up a ringing action at approximately 240 kHz. The ringing decays after a few cycles because it is not sustained immediately following the horizontal retrace pulse.

This ringing, appearing in the vertical yoke windings, exhibits itself as severe ringing on the left side of the screen. Thus, the raster lines for the first two inches of scan appear as sine waves. This condition is most apparent when the set-up switch is in the "set-up" position. These yoke plugs will develop poor pin connections.

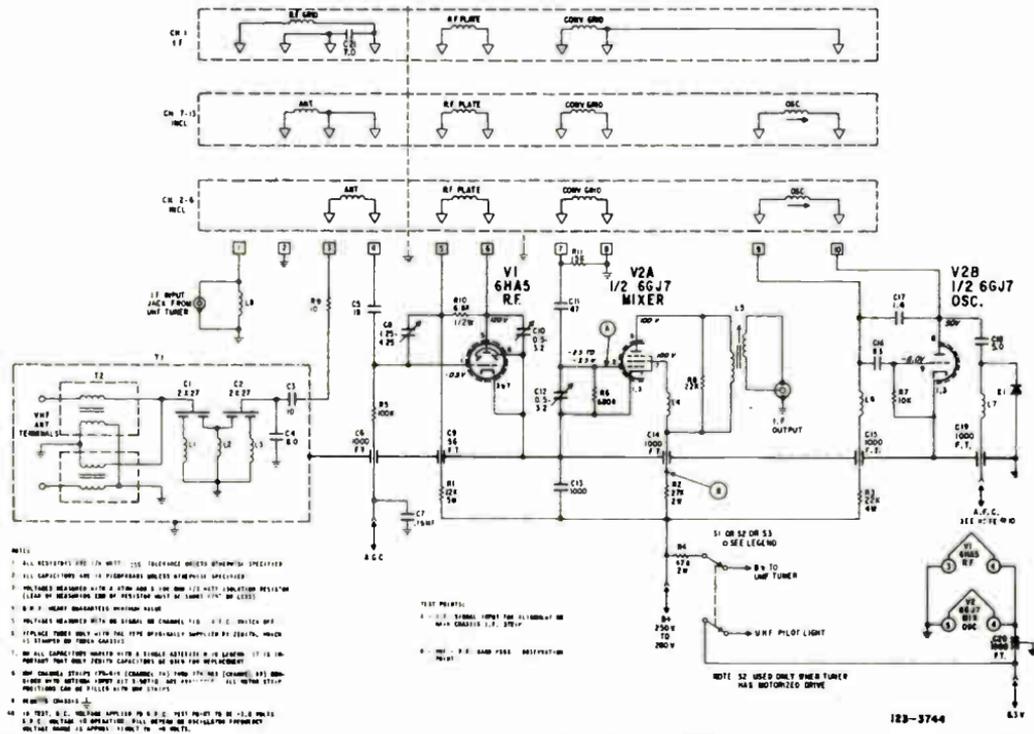
FIGURE 160

When this color receiver was first turned on, the VHF stations could not be fine tuned properly and the oscillator appeared to be drifting. The fine tuning control also had very little effect. The AFC control voltage was removed, but no change was noted. After the set would warm up (about 20 minutes) the fine tuning then performed normally. The two tubes were changed and then a good tuner cleaning was performed, but no improvement was noted.

The schematic for this type 175-595 VHF tuner is shown in Fig. 160. After a few more checks, the problem was narrowed down to an intermittent varactor AFC diode (Part Number 103-146) in the tuner oscillator stage. This is diode X1 in Fig. 160. An ohmmeter check revealed "infinity" readings in both directions.

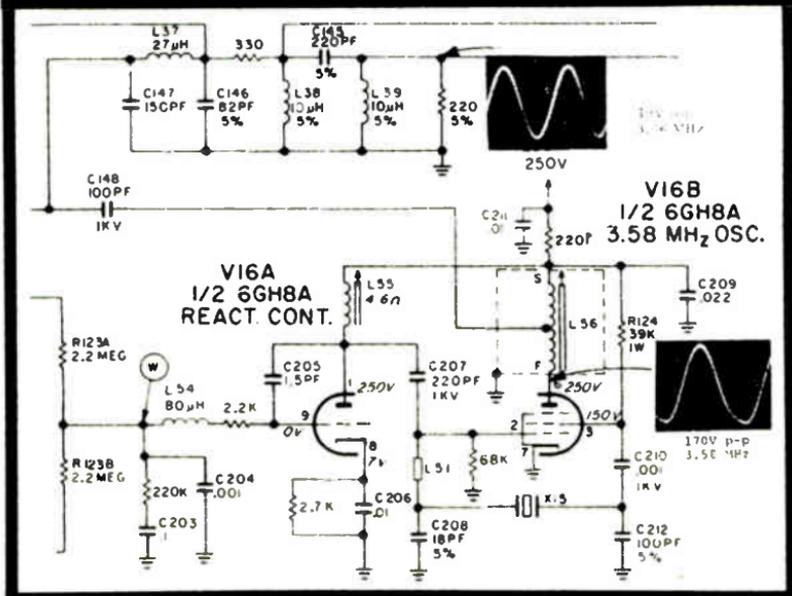
FIGURE 161

Note: On some chassis the coil (L54) will be connected to grid of V16A. Coil L54 should be connected to test point "W" and the 2.2K resistor goes to the control grid. The late production chassis have this change which is correctly shown in the circuit of Fig. 161.

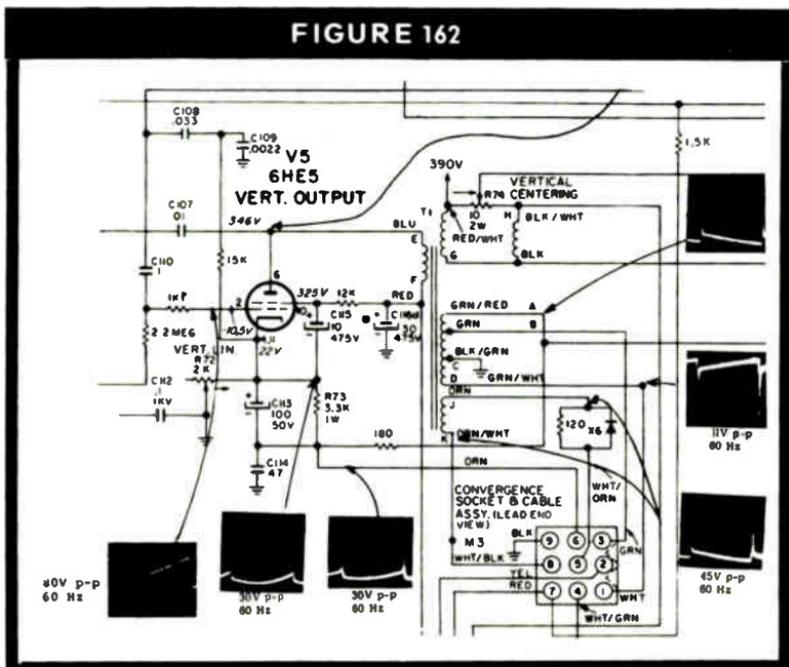
FIGURE 162

The sound was normal on this set, but only a narrow, white horizontal band across the center of the screen was visible, thus indicating very little vertical deflection. The tubes were good and the vertical height and linearity controls had no affect on the vertical deflection. We first suspected a faulty cathode capacitor, C113, see schematic in Fig. 162. However, even though this capacitor has been known to be a trouble maker, it was found to be good in this chassis. The vertical oscillator was also operating properly. The trouble was located as an open 12K screen control resistor located at pin 10 of the vertical output tube, V5. Replace the 6HE5 tube, since it probably shorted and caused the resistor to fail. Also check capacitors C115 and C116B. This is a rare vertical deflection problem and can be easily overlooked.

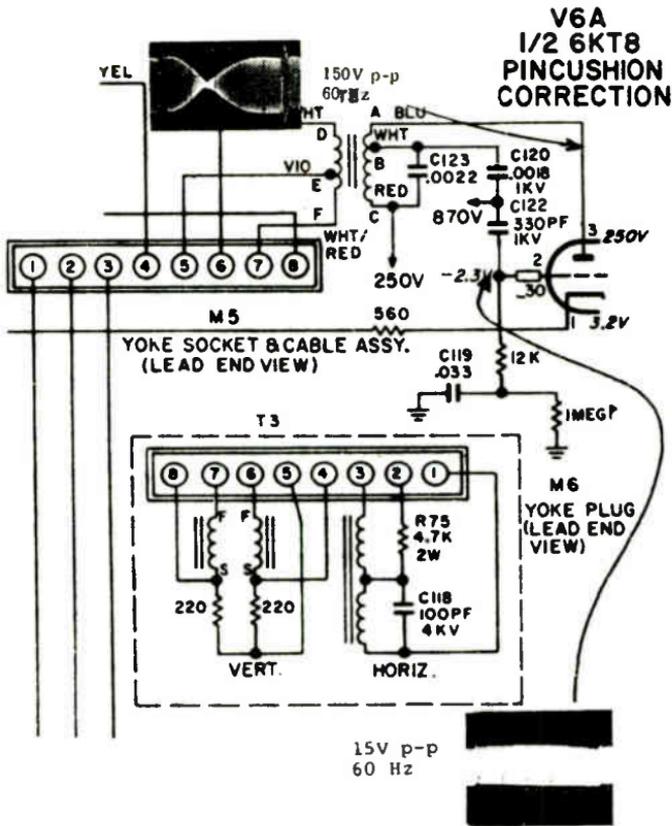
FIGURE 165

When confronted with a weird looking pattern on the TV screen, don't overlook the dynamic pincushion circuits as a probable cause. Slight component variations and malfunctions in these circuits may cause some unusual or misleading patterns. The Zenith 16Z8C19 pincushion circuit shown in Fig. 165 will serve as a reference.

On some chassis, the cathode of this tube is connected directly to the vertical output transformer. In this case, the 60 Hz AC voltage may be strong enough to modulate the vertical sweep and cause the bottom of the raster to "pull-up" two or three inches and take on a "breathing" action also.

Notice that the unfiltered boost voltage is coupled to the grid of the tube via a 330 pf capacitor (C122). The AC component of this voltage is used to achieve the desired output waveform. A leaky or shorted capacitor (C122) will cause an excessive amount of DC voltage to be applied at the grid and cause extremely high current to be drawn through the tube.

This excessive current will damage the tube, overheat the cathode resistor, if used, and blow the fuse when the tube finally shorts. Check or replace capacitor C122 and the resistor, if used, before replacing the tube and fuse.

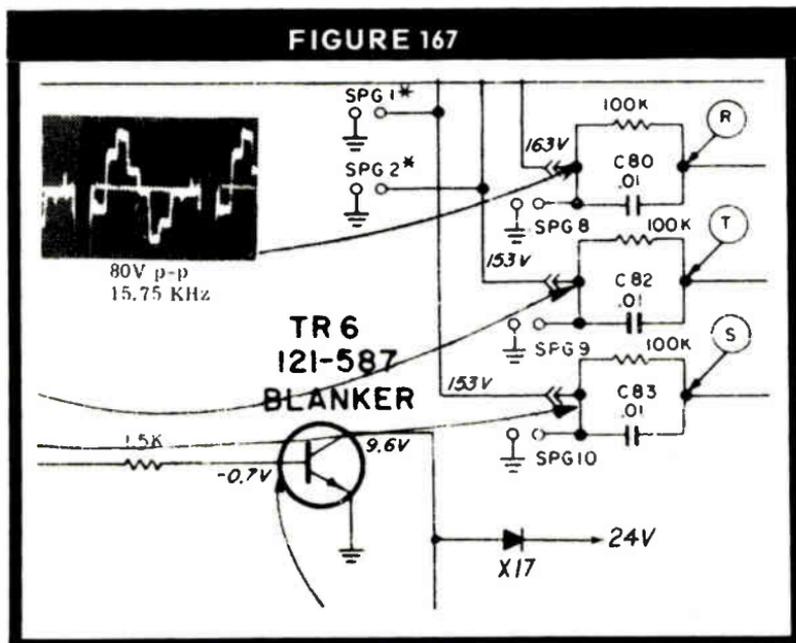
This color receiver displayed a picture with the "bends" and it appeared as if it were due to an AGC fault. However, the AGC section checked out good.

The oscilloscope was used to check all of the B+ supply voltages, and horizontal pulses were found on the 24-volt bus. The trouble was isolated to a defective (shorted) diode located in the blanker transistor circuit which caused horizontal pulses to appear on the 24-volt bus and also on the AGC transistor collector. Check or replace diode X17, shown in Fig. 167, to correct this trouble.

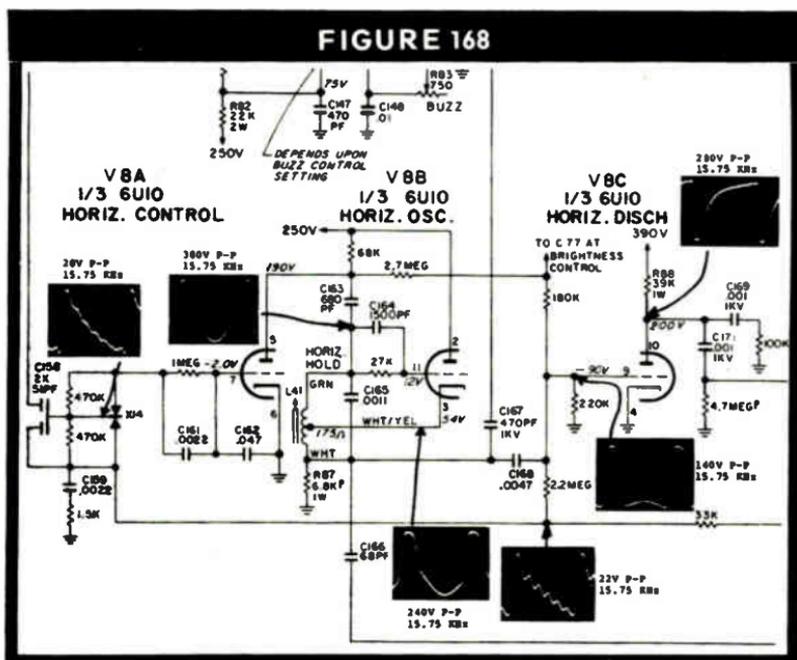
FIGURE 168

This same trouble will cause many, interrelated symptoms. These symptoms are as follows:

May also cause buzz in the audio.

The probable cause for all of these troubles is a defective 6U10 tube. Check or replace the 6U10, since it drives the HV sweep circuitry, keys the burst amplifier to obtain color, controls the 3.58-MHz oscillator, and keys the AGC stage. This tip could save you many hours of needless troubleshooting time. See the schematic of this circuit in Fig. 168.
